A Vision for Water Resource Management and Climate Resilience within the Open Spaces of the Sonoma Developmental Center (SDC)

October 2023

Prepared by Steven Lee and Jack Hines, Sonoma Ecology Center Research Program

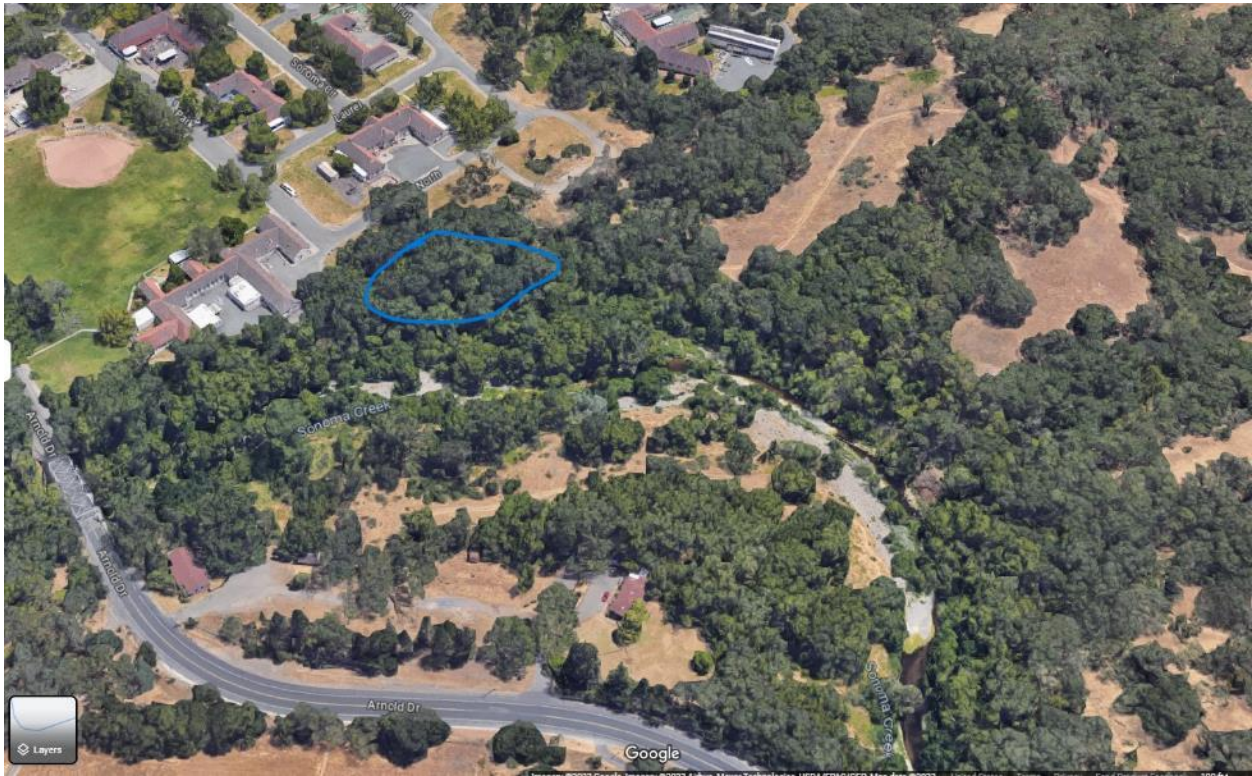
On the outside bend of Sonoma Creek between the two bridges, west side of the creek on the right bank near the Wagner building (see Figure 5) lies a deep section of riparian area perched atop a historical floodplain area that is no longer inundated, even during the largest storms. The reason it is no longer flooded by the creek is because the entire creek system has been degrading (downcutting and lowering) through the years. Remnant floodplain areas like this occur throughout upper Sonoma Creek, though none quite as expansive as this one. As development of the facility progressed in its early years the lower portion of an unnamed tributary draining the hillside above the cafeteria building was modified through earth moving and the creek was channelized in one section and redirected through an underground culvert at its lower extent before daylighting onto this relic floodplain. Rather than allowing the water to spread out upon that floodplain, a drainage ditch was constructed across the floodplain bringing those storm flows (a combination of natural drainage water and street/roof runoff) directly to the active channel of Sonoma Creek (Figure 6). As can be found on soil survey maps of Sonoma Valley (see Figure 7), while much of the SDC open space areas consist of poorly draining adobe soils, this alluvial, relic floodplain is well draining and highly favorable for groundwater infiltration. What is proposed here is to eliminate the drainage channel between the storm drain terminus and the active creek channel, and recontour this relic floodplain area to encourage retention and infiltration of storm flows. A bit further northwest, another drainage system, (Corridor Creek South), empties onto this same relic floodplain terrace. A channel also cuts across the flood plain at this location similarly delivering storm flows, and water treatment system overflows, directly to Sonoma Creek with little opportunity for infiltration. Terrace recontouring would extend to this area to enable retention and infiltration for both of these flow inputs. Additionally, there is a separate and somewhat higher floodplain terrace in between this aforementioned terrace the developed campus where two smaller storm drains terminate. Recontouring on this terrace would provide a separate infiltration zone with any overflow water cascading the lower retention terrace. Based on our calculations of drainage area and average rainfall, we

Figure 5. Water Retention Opportunity #1 location outside of bend in creek and just north of developed campus. Satellite view is facing south.

estimate that well over 100 acre feet of water drains to these terrace areas annually. A significant amount of that volume could be retained at this site and allowed to feed more slowly to Sonoma Creek through the subsurface alluvium. Allowing for such retention and infiltration at this site would also lessen sediment inputs to Sonoma Creek from these flow pathways. Contouring would be done around the larger, high value trees to maintain proper riparian habitat functions. This area is part of the critical, pinch point portion of the wildlife corridor and so such a project would create short term impacts to wildlife. But there has been a long history of human activities throughout all of these SDC open spaces, including within this section of riparian habitat, and yet we are today placing high value on these lands for their habitat functions. The long term benefits of water infrastructure projects like what is proposed here by far outweighs the short term impacts of doing such recontouring work. This water retention and infiltration opportunity was conceived while SEC was in the middle of a visioning process to explore and promote fisheries restoration opportunities in upper Sonoma Creek (see <https://sonomaecologycenter.org/restoration-vision/>). As part of that process some initial restoration concepts and cross sections were drafted for the selected restoration sites. Appendix 2 displays schematics for this opportunity area excerpted from our Upper Sonoma Creek Restoration Vision document. These drawings do not depict the upper terrace area mentioned above as that component was conceived at a later stage. This project, and others like it, should be included as part of the SDC redevelopment process.

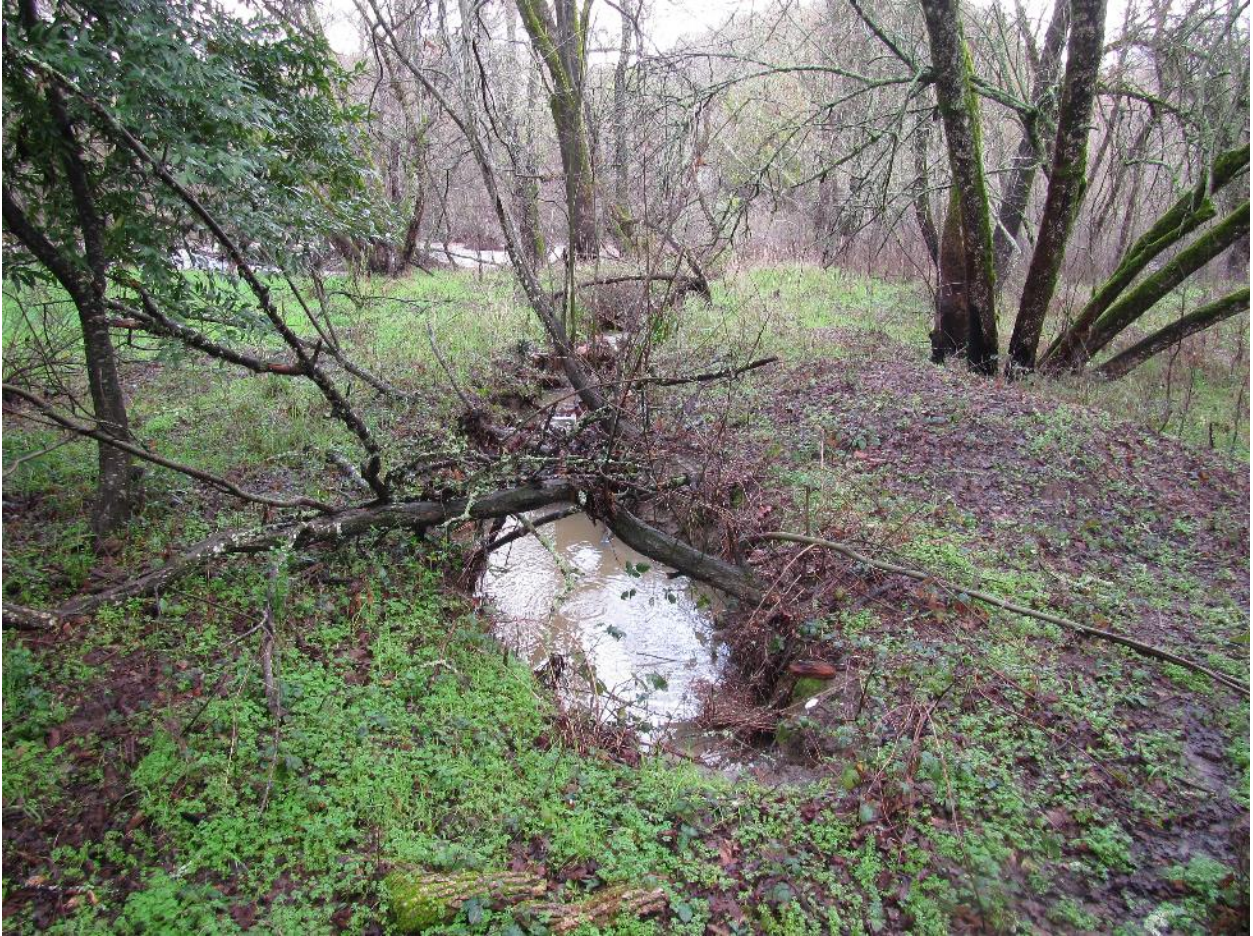
Figure 6. Water Retention Opportunity #1 Site showing stormwater outflow running straight to creek across relic floodplain without opportunity to percolate to groundwater.

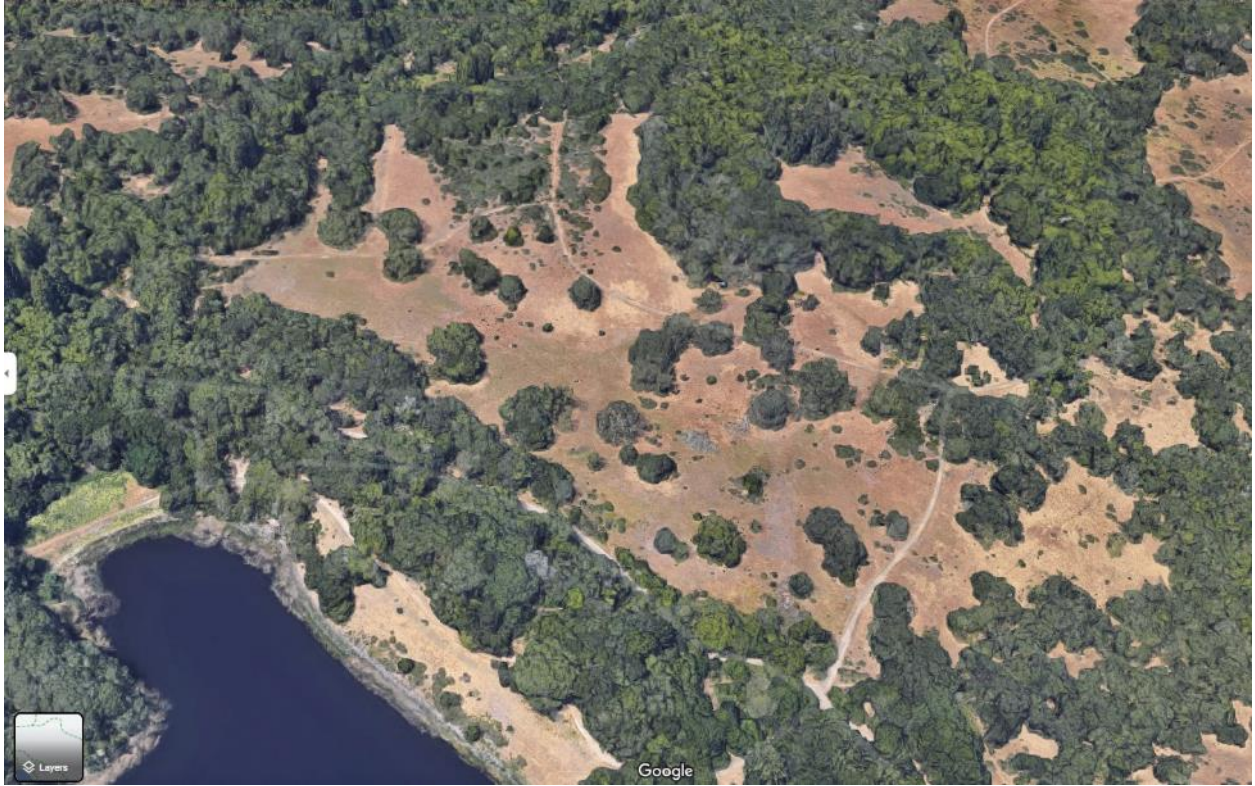
Just below Fern Lake a great meadow exists in an area that, through major earth moving, could likely have supported another lake of the same size (see Figure 8). This meadow area has very high habitat values and of course we aren't suggesting anything like that. But by taking some modest steps, significant wet season precipitation and drainage water could be retained at this site in a way that would reduce peak storm flows in Asbury and Sonoma Creeks, lessen sediment inputs, and add significant seasonal wetland habitat values to this portion of the open space. Some groundwater replenishment could occur as well as the soil maps (Figure 7) show the area to have marginal, but not poor, drainage capacity. Much of this moderately sloped meadow area drains to a low bowl like area (Figure 9) and from there it transitions abruptly into a very narrow, steeply sided and high gradient sluice canyon (Figure 10) which seems to be the byproduct of historic landslide activity. Based on our calculations of drainage area and average rainfall, approximately 48 acre feet of winter precipitation drains directly to this area. As it stands, much of this water flows down this sluice during storm events eroding the fine sediments of the sluice banks along the way and delivering those sediments to Asbury and Sonoma Creeks. At the far end of the sluice canyon (Figure 11) that drainage continually causes washouts on a fire service road it crosses and also further erosion from there as it drops down a steep slope towards Asbury Creek (Figure 12). With very little impoundment work at this meadow/canyon transition point a significant volume of water could be retained in the lower, bowl portion of this meadow.

Figure 8. Great meadow below Fern Lake.

Such an impoundment could be installed with a small outlet at the base to allow flow to slowly drain to the creek following the storm peak. Or it could be designed to encourage longer duration retention and infiltration. Further, an artificial channel (Figure 13) running from the Fern Lake overflow, which cuts through and is causing headcutting issues (Figure 14) at the north end of this meadow, could very easily be rerouted to instead drain to this same water retention area at the sluice canyon. Rather than running a new flow channel all the way through the meadow, the rerouted channel could be made to follow grade south toward the retention site for as short a distance possible before fanning out and continuing as sheet flow the rest of the way down slope. Whether designed for peak flow avoidance or groundwater infiltration, such a site would certainly foster wetland development within and at the margins of the retention zone. Following study and engineering, reasonably little construction effort would be required to implement such a project, and once in place it would represent a net benefit to the habitat values of this great meadow site.

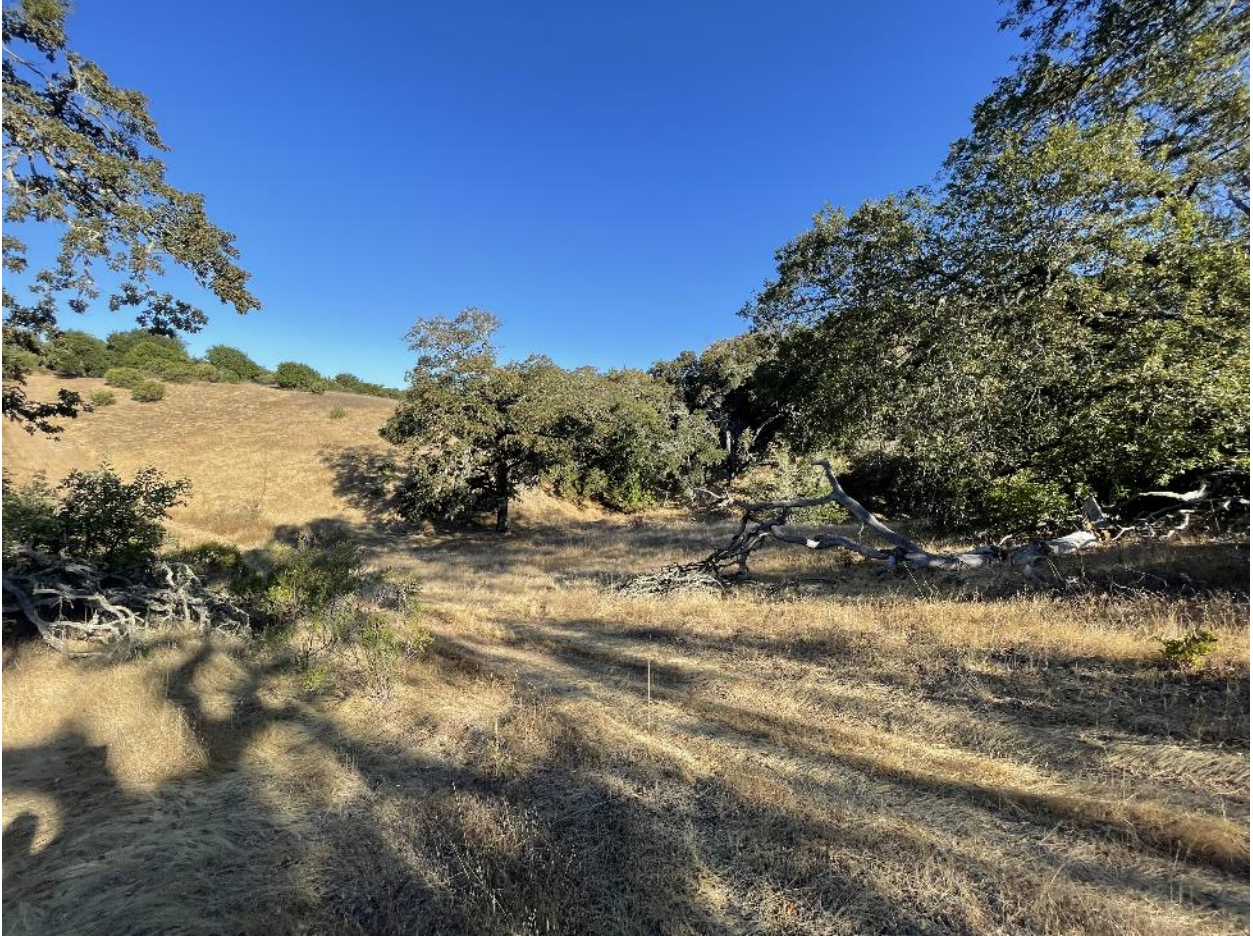
Figure 9. Water Retention Opportunity #3 Sluice canyon impoundment at low point of great meadow below Fern Lake..

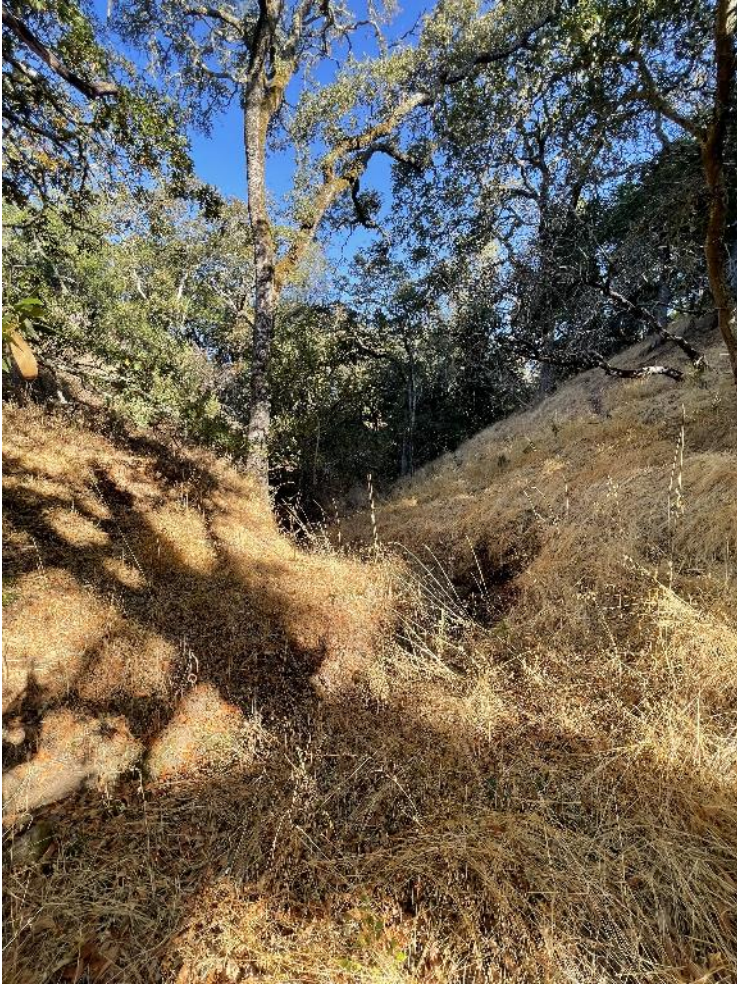
Figure 10. Retention Opportunity #3, sluce canyon entrance.

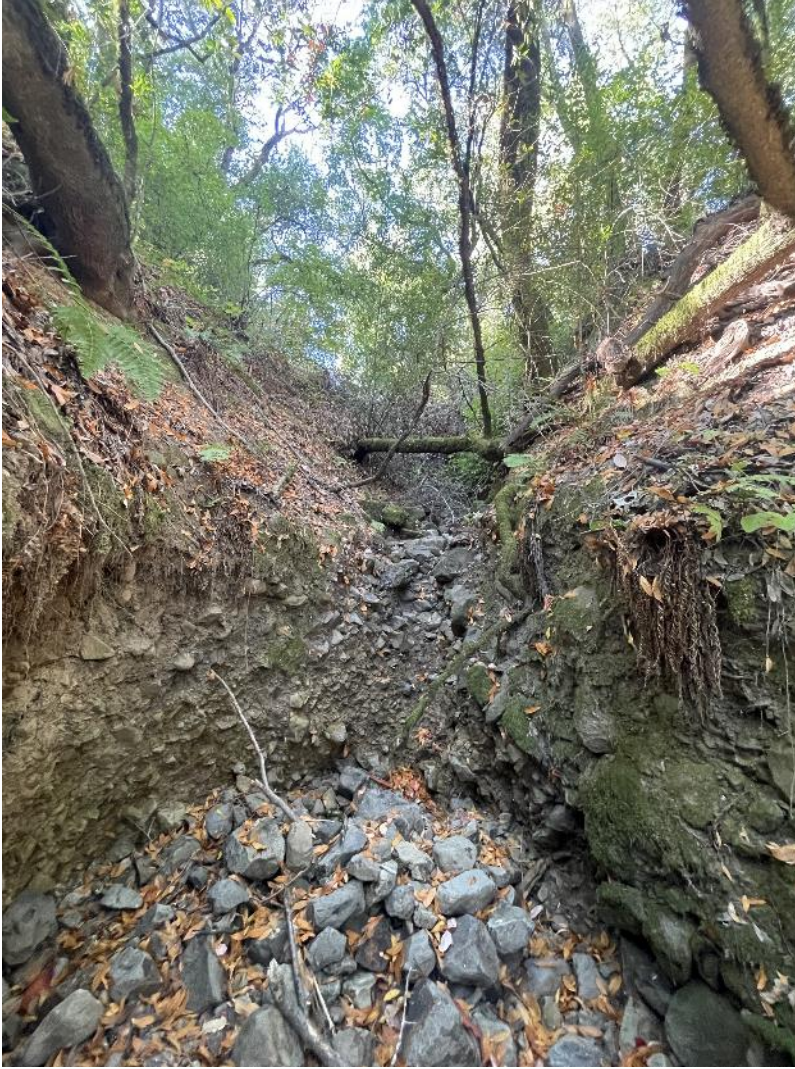
Figure 11. Retention Opportunity #3, sluice canyon exit with headcut visible.

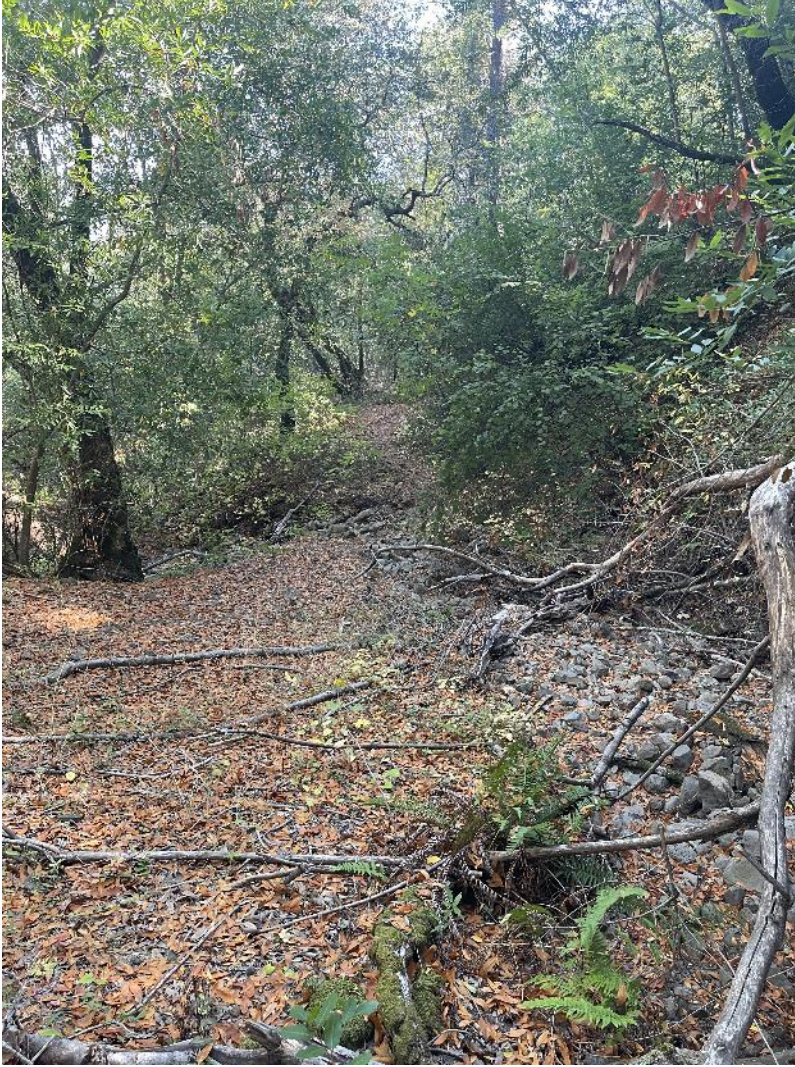
Figure 12. Water Retention Opportunity #3, road and drainage erosion below sluice canyon.

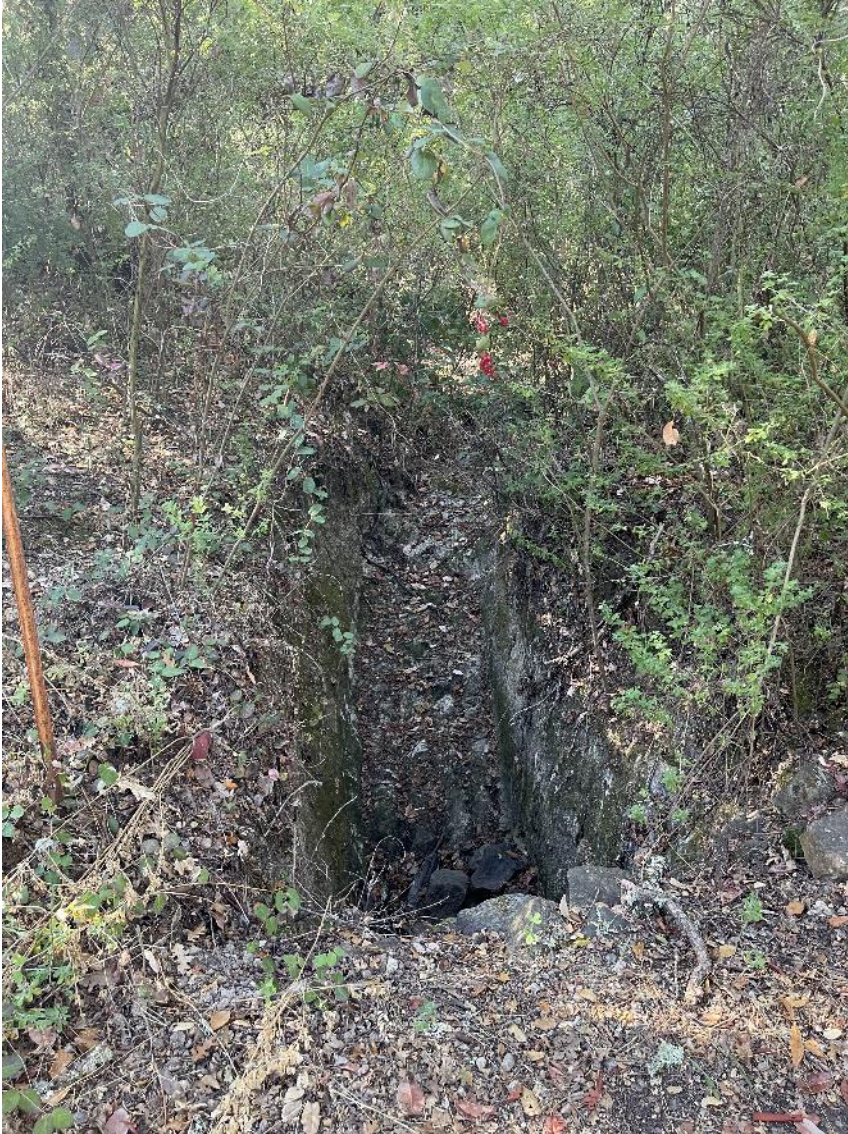
In the meadow below (east of) Fern Lake, a man made overflow channel (Figure 13) connecting the lake spillway to the Roulette Creek tributary of Asbury Creek has been headcutting in recent years. In the last rainy season (2022/2023) this headcut advanced across an important fire service road making that road impassible (Figure 14). As was discussed above in water retention and infiltration Opportunity #3, we feel it would be best to redirect that lake overflow via sheetflow into a water retention zone to the southwest. In so doing, this section of the manmade channel (including the headcutting zone) would be restored back to meadow habitat, thereby addressing this chronic erosion site.

Figure 13: Constructed channel leading from Fern Lake overflow spillway to Roulette Creek via Great Meadow. Shown here is the place where the channel crosses the primary service road leading to the diversion point on Asbury Creek.

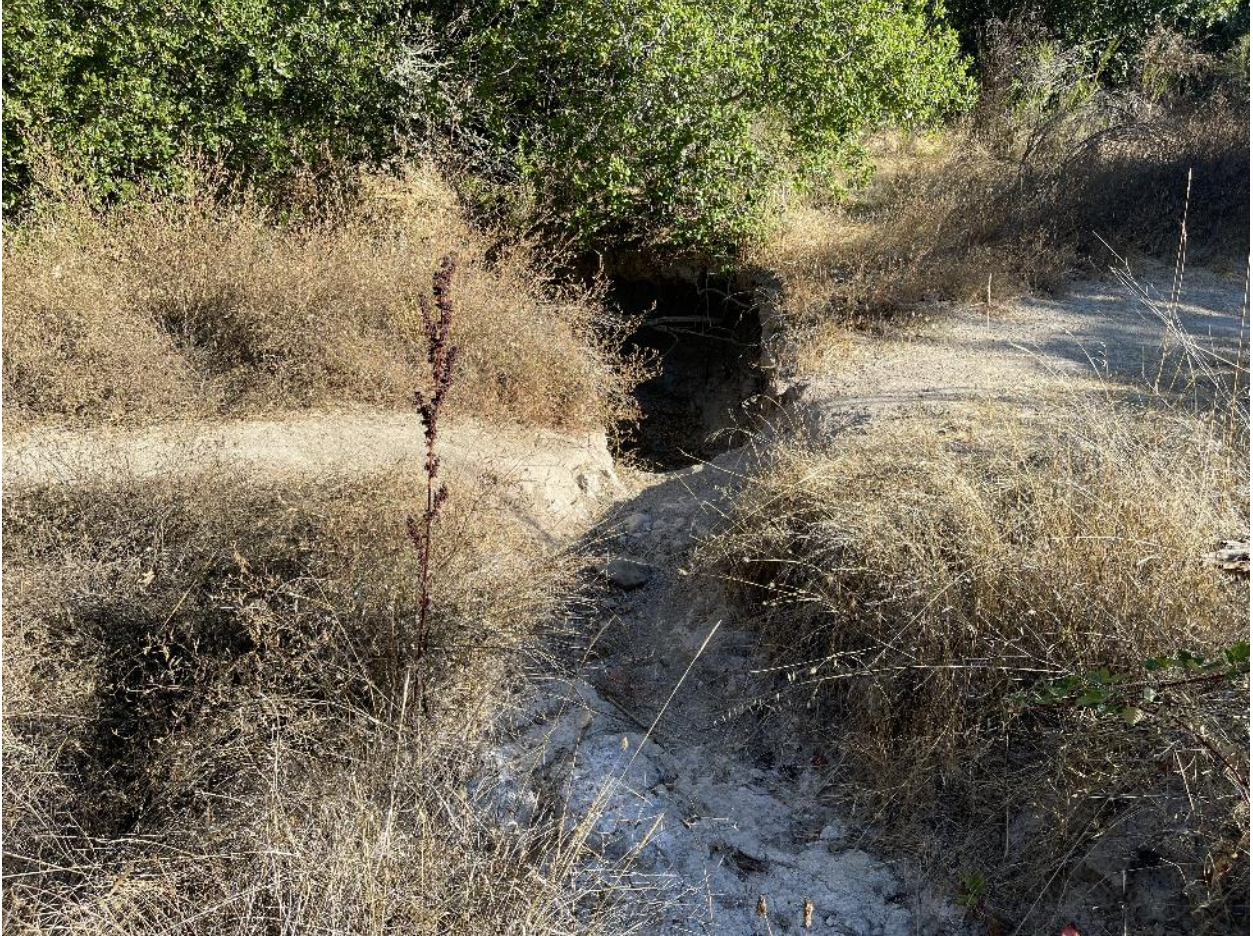
Figure 14: Chronic Erosion Site #4, Headcut on constructed Fern Lake overflow channel impacting fire service road. Road is currently impassable by emergency vehicles.

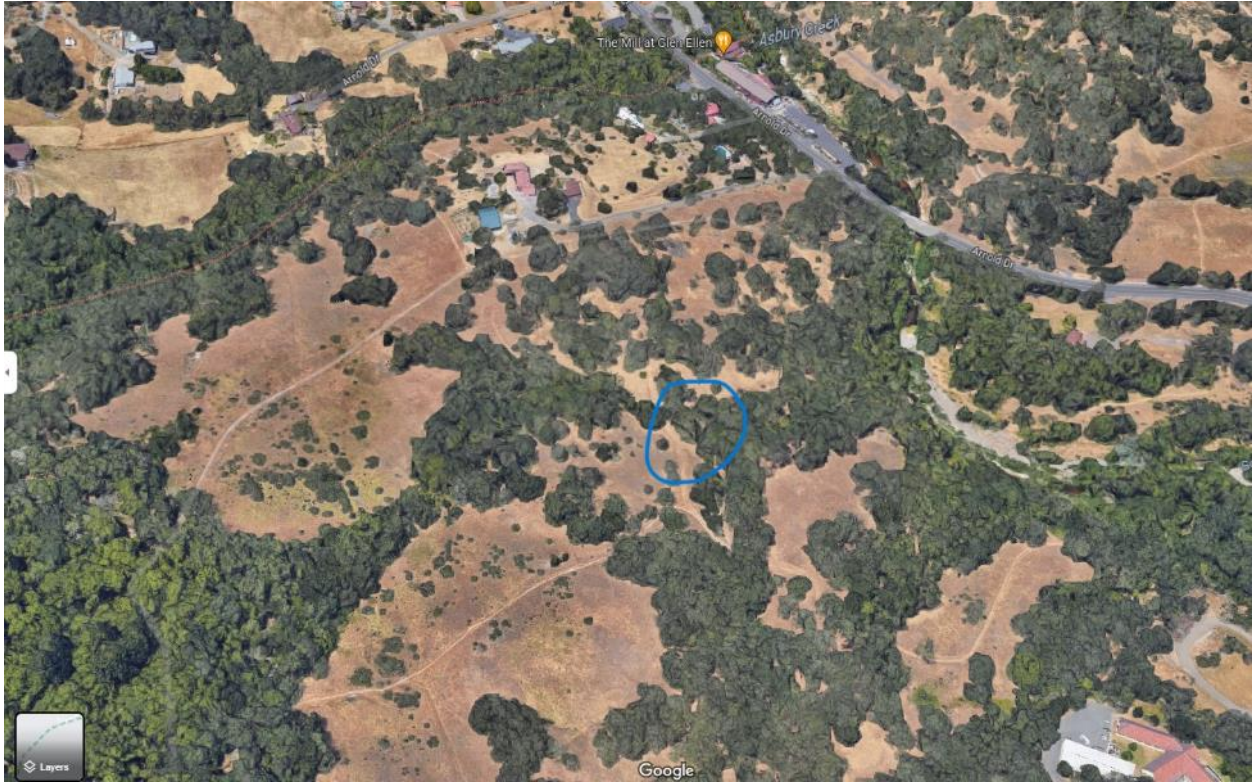
Closer to Sonoma Creek within the SDC subwatershed, two branches of the Corridor Creek North tributary come together right at the spot (Figure 15) where they begin to descend to Sonoma Creek down a steep and highly eroded channel cutting through the low spot between two hilltops (Figure 16). Upstream from that steep channel the subwatershed forms a bowl at the junction of the two drainages. Over the past decade or more a headcut emerging from that steep channel has been migrating upstream along both branches of the tributary. During the 2022-2023 rainy season the advancing headcut on the northern of the two branches finally made its way across a fire service road which traverses this bowl area (Figure 17). That road is currently impassable by emergency vehicles. Based on our calculations over 200 acre feet of precipitation drain to this area annually. This bowl area is more steeply sloped and is a less favorable retention and infiltration site than the aforementioned site in the great meadow. But if there was motivation to do so, proper placement of an impoundment of some size could detain a significant amount of water and at the same time could help address the chronic erosion and channel downcutting occurring there. Because this bowl is squarely in the middle of the SVWC narrowing point, there is motivation among SEC and other local natural resource advocates to deemphasize human use in this area and instead route public access pathways and trails around the periphery of this area. Once infrastructure was in place, water retention in this area would be fully consistent with wildlife corridor functioning and would, in fact, enhance wildlife benefits due to the additional aquatic resources which would develop there.

Figure 15. Water Retention Opportunity #4 Impoundment and channel aggradation at Corridor Creek North branching zone.

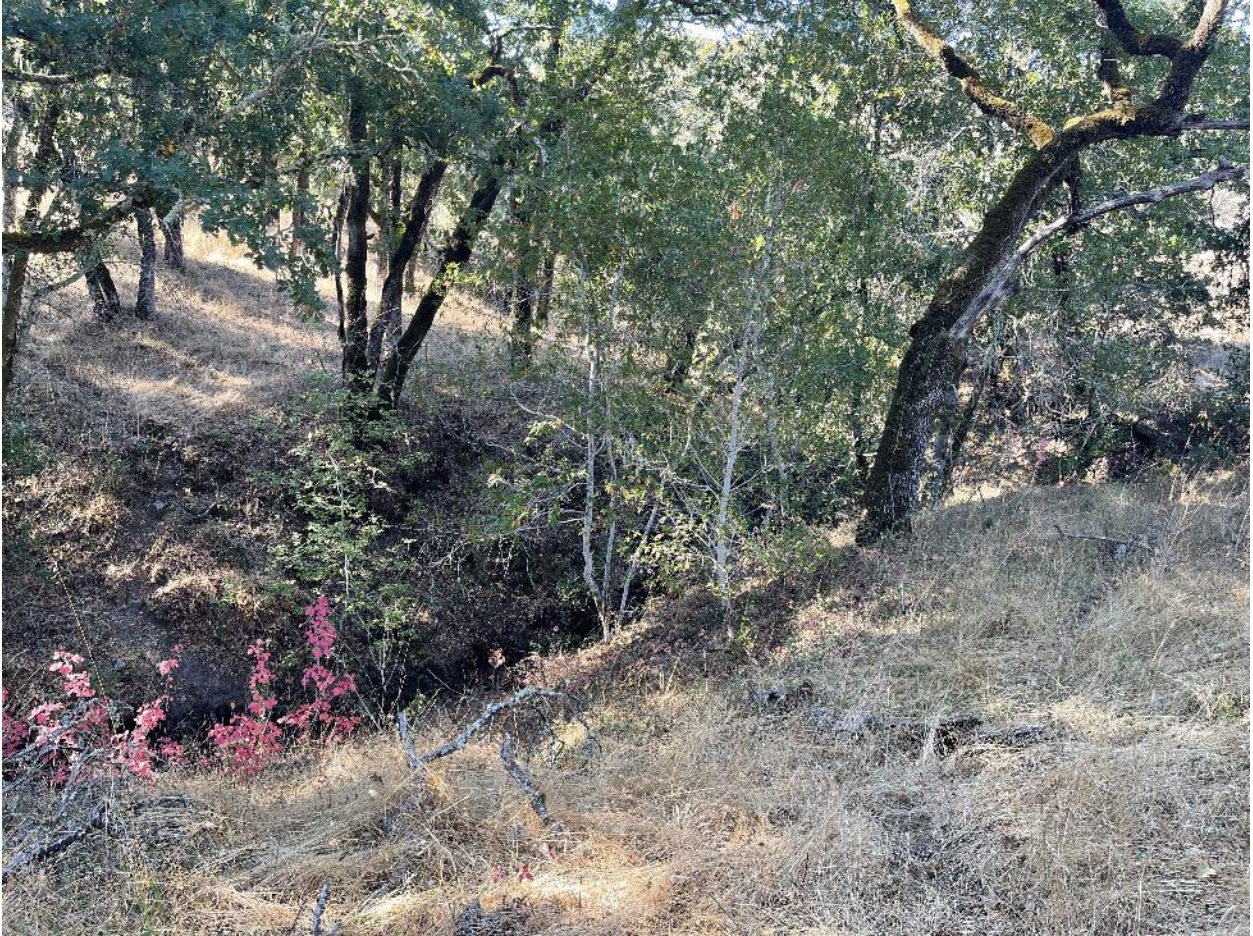
Figure 16. Water Retention Opportunity #4 Below the bowl of the Corridor Creek North branch point where steep hill slopes occur to either side of a high gradient, eroding creek section.

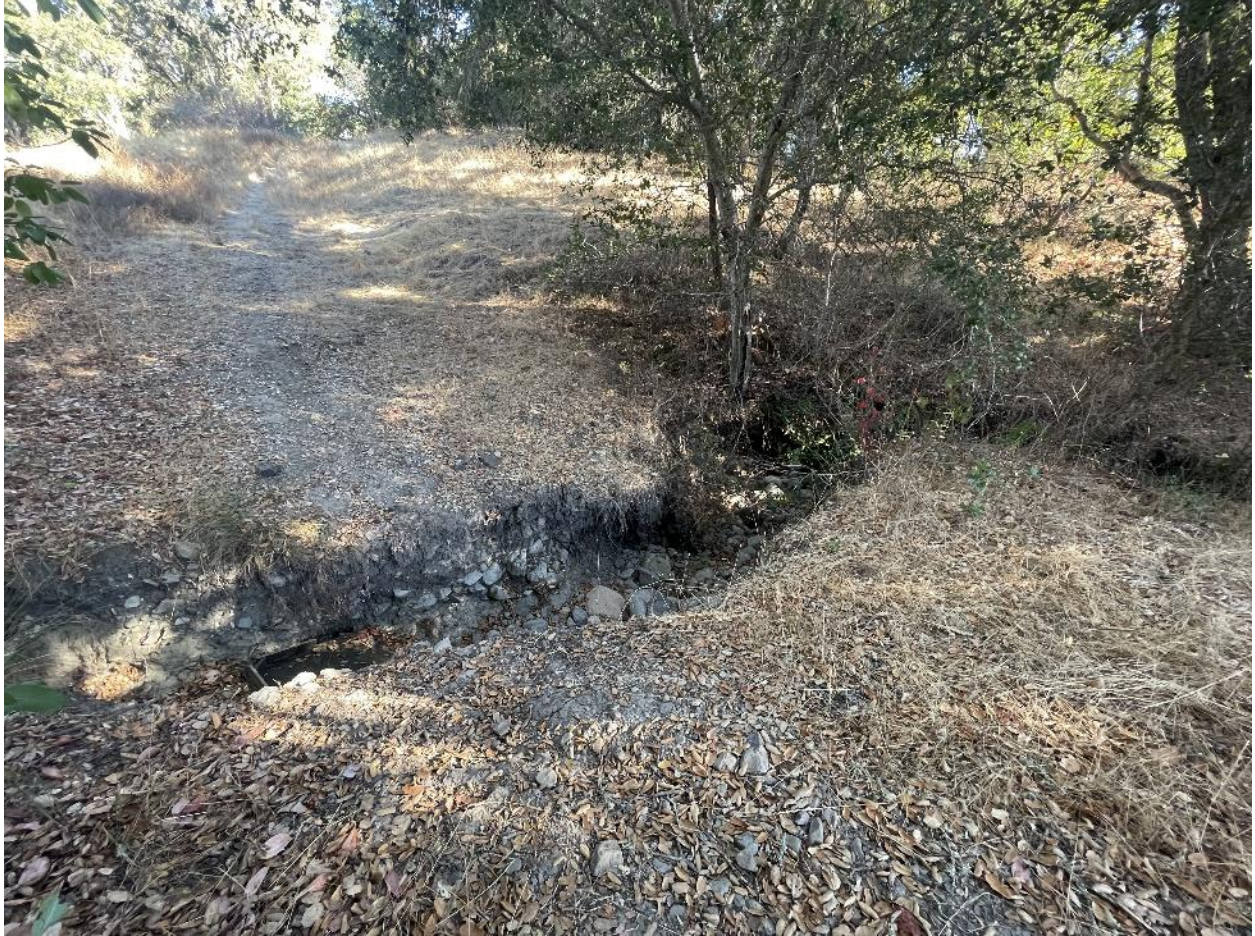
Figure 17. Water Retention Opportunity #4 Headcutting section of Corridor Creek North just upstream of the tributary branch point. A fire service road has become impassable at this location.

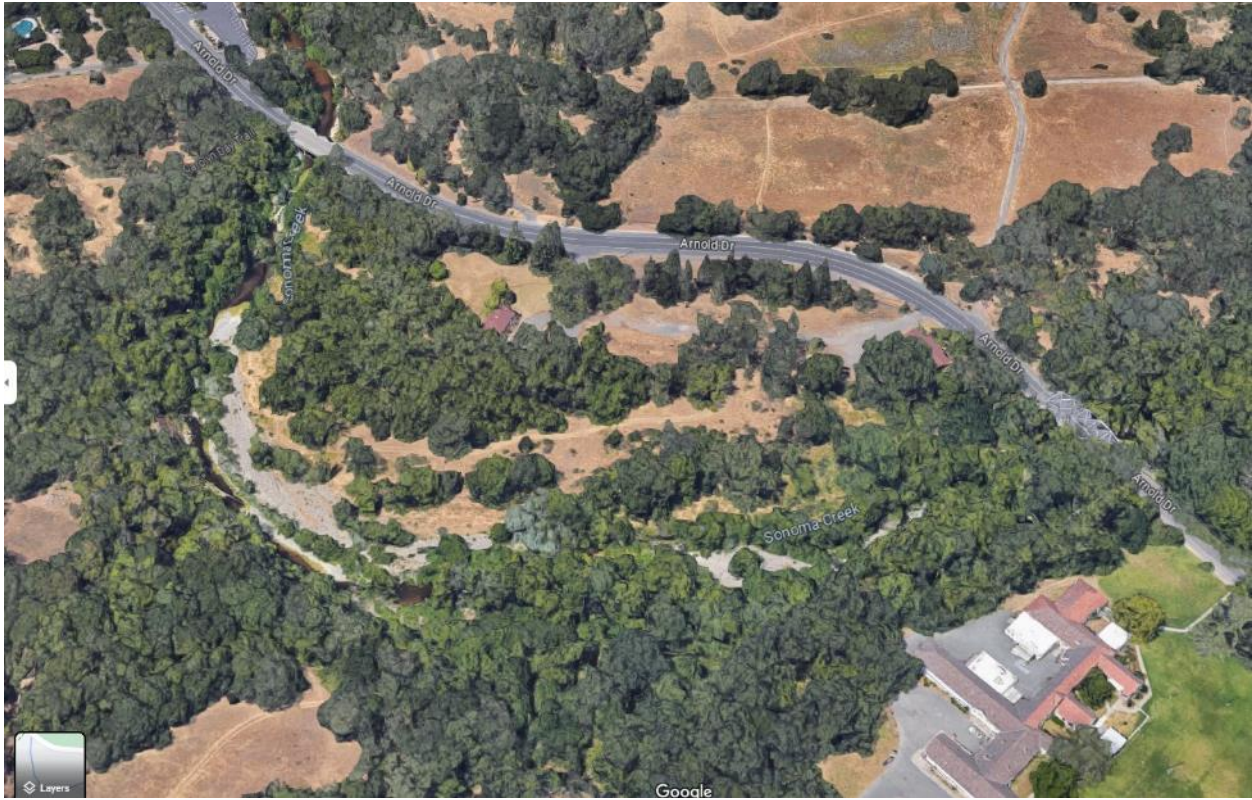
East of Sonoma Creek and west of Arnold Drive between the two bridges, lies the most significant floodplain zone in the entirety of Sonoma Creek (Figure 18). In appearance, this area is like a scaled down version of Sonoma Water's Mirabel infiltration site on the Russian River where water is diverted from the river during higher flows and conveyed into a series of infiltration basins. During high flow events Sonoma Creek already spreads out onto the lower floodplain on the inside of the river bend allowing for some retention and infiltration into the water table, but it does not have access, even at the highest flow events, to the higher, relic alluvial areas further inside the bend (Figure 19). A set of infiltration basins similar to Mirabel could be constructed in this area, not for subsequent, domestic water supply extraction, but to promote increased baseflow in Sonoma Creek during the dry season. These days the SDC reach of Sonoma Creek represents the transition zone between the upper watershed, where flows remain cool enough for summertime rearing of steelhead and other anadromous fishes, and the middle watershed where flow remains mostly perennial, but the water temperatures are starting to get too warm for salmonid rearing. Within the SDC reach you start to see increased numbers of introduced species like sunfish, large mouth bass and bullfrogs in the creek. It would take a lot before we saw dry season rearing of steelhead throughout all of Sonoma Creek like there used to be. But anything we can do to foster improved summertime base flow and inputs of cool groundwater into this part of the creek will allow this transition zone to shift back downstream toward Madrone Road or even into the Springs area. This region on the creek bend between the two bridges IS the narrowest and most critical pinch point of the Sonoma Valley Wildlife corridor. Until recently there were two active and full-time family homes, plus other SDC facilities activities occurring in this area...and yet it remained highly valuable as a wildlife crossing zone. We at SEC would like to see no redevelopment and no nighttime lighting in this area. We feel that fences should be removed and that the entrance to the Sonoma Valley Regional park should be relocated to another area within the SDC redevelopment area. Rather than just have the one safe road crossing underneath the Jim Berkeland bridge, we should explore other opportunities for providing safe passage across/under Arnold Drive in this area. But we also believe that short-term impacts of constructing water resources/infiltration infrastructure within this critical area is manageable and that it is possible to have the project completed and passively operated in a way that does not hinder the wildlife habitat and crossing values we care about so much for this area.

Figure 18. Water Retention Opportunity #5 Floodplain retention on the inside bend of Sonoma Creek between two bridges.

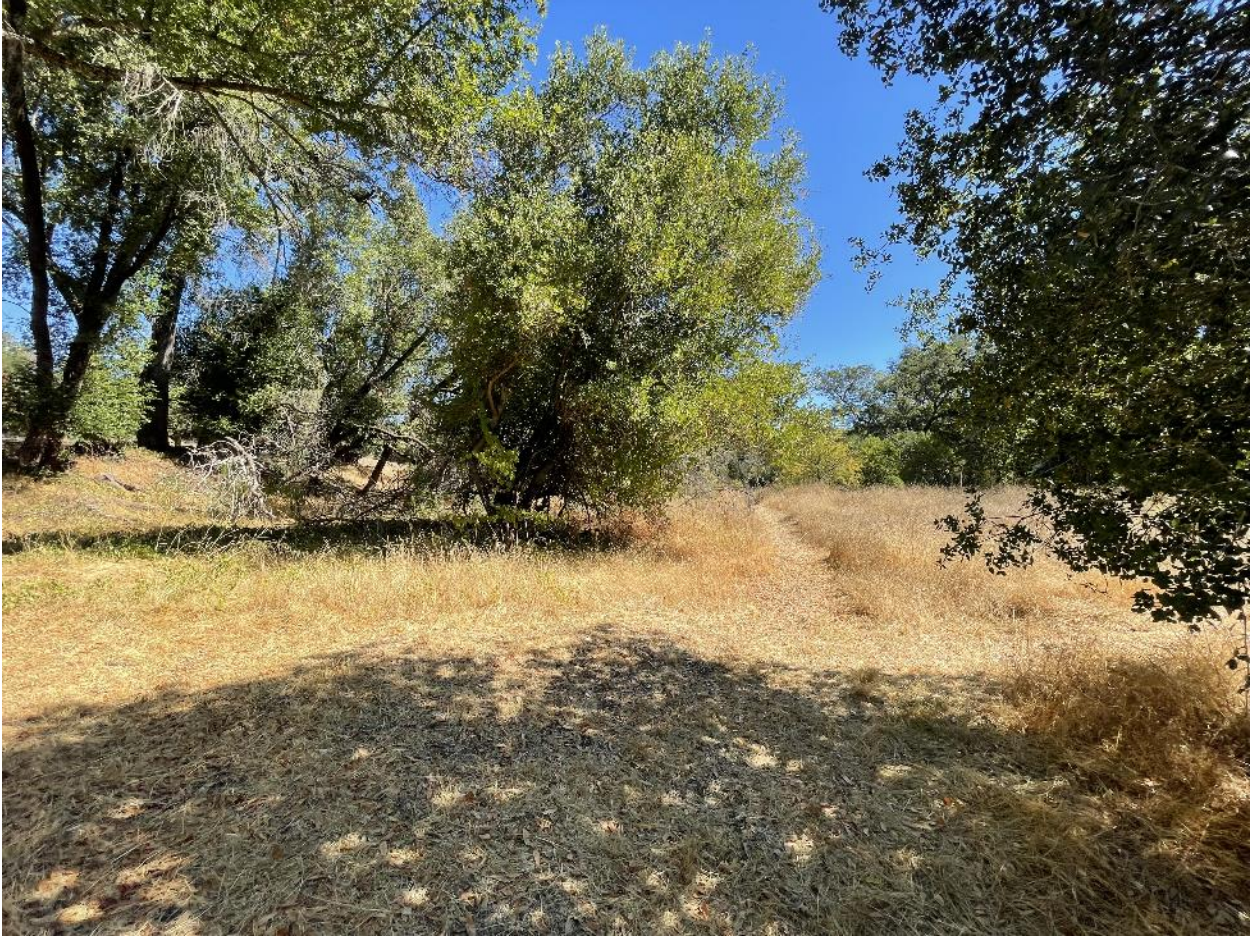
Figure 19. Water Retention Opportunity #5 Floodplain retention on the inside bend of Sonoma Creek between two bridges. High alluvial terrace area shown. An even higher terrace area exist to the left of this photo where an old residential building is located.

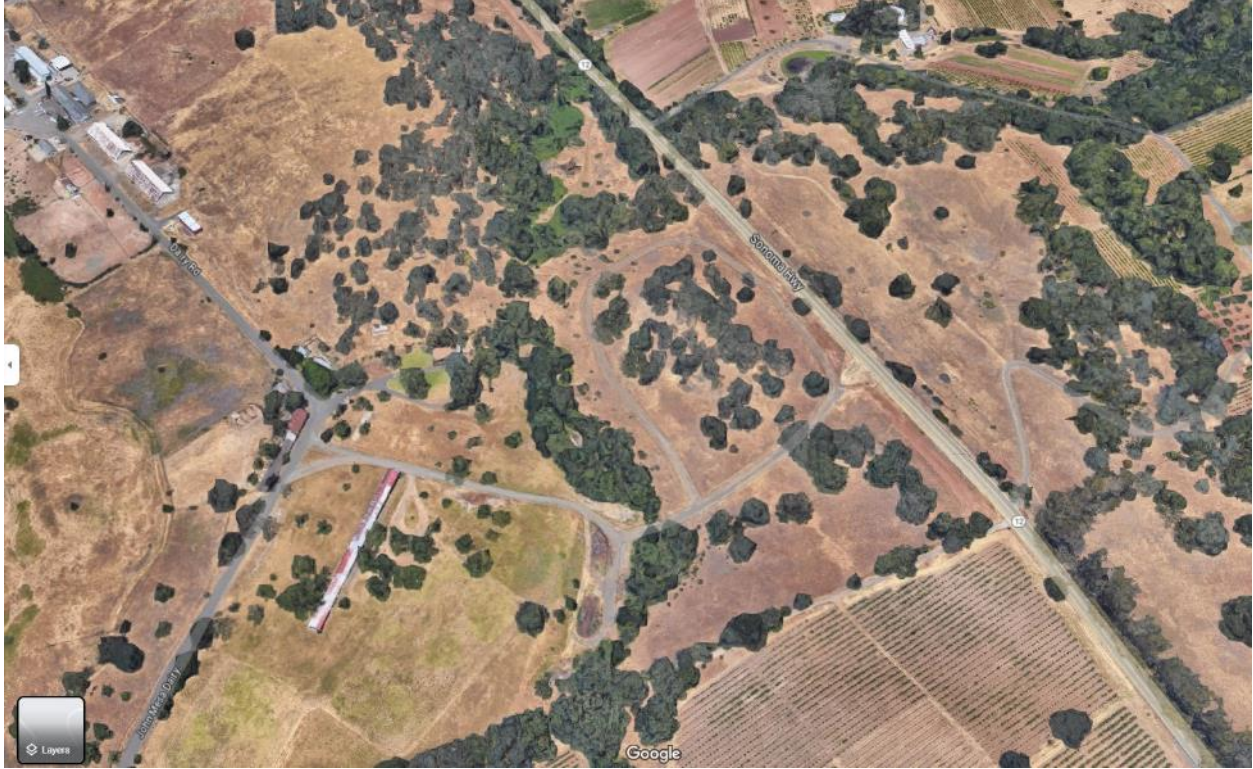
Figure 20. Water Retention Opportunity #6 BDAs and other water retention opportunities in Butler Creek at the far southeast corner of the SDC open space lands.

East of Sonoma Creek and east of the SDC redevelopment footprint exists a section of Butler Creek (a tributary in the Hooker Creek subwatershed) which bisects the far southeast corner of the SDC open space (Figure 20). This is a very flat reach of stream corridor with rises to either side (Figure 21) and with two branches extending from a confluence point to separate culvert crossings under Hwy 12. Blackberry brambles surround much of the stream channels in this area. Based on our calculations nearly 1800 acre feet of precipitation falls upon this catchment area annually. And groundwater recharge potential on this portion of the SDC open space appears favorable (Figure 7). Previous efforts to detain water in this area are evident (Figure 22) which is testament to the favorability of this area for water retention. As we have come to understand the severity of declining streamflows and groundwater levels, we have begun to invoke the lessons of beavers, who are natural ecosystem engineers, as a means of promoting water retention in the landscape. Beavers have returned to the watershed and are beginning to exert their restorative influence in portions of Sonoma Creek causing areas which had gone dry during the summer months to remain wet and ponded all year long (Figure 23). In watershed areas where beavers have yet to return, humans can simulate their actions through the installation and maintenance of Beaver Dam Analogs (BDAs): vegetation based structures that partially impound stream channels, retain water and enhance aquatic habitat just like beaver dams do (Figure 24). Such structures don't work everywhere; their installation and efficacy require a relatively flat channel gradient and sloping terrain to help contain retained water. This reach of Butler Creek has that perfect combination of characteristics. It also represents an important linkage point at its upstream end for the Sonoma Valley Wildlife Corridor, so improving habitat functions in this relatively out-of-way portion of the SDC open space will pay additional dividends for migrating wildlife. We propose studying the area and installing a network of BDAs all through this entire reach to create several step pools of flooded habitat from the southern SDC property line to the eastern line along Hwy 12. Several stretches of eroding banks within this reach can also be addressed simultaneously. Pursuing and implementing such an approach would not be inconsistent with the improvement of a SDC to Hwy 12 connector road. Such a road is being proposed as part of the redevelopment plan, which would likely follow the progression of an existing fire service road crossing through this area near the downstream end of the reach.

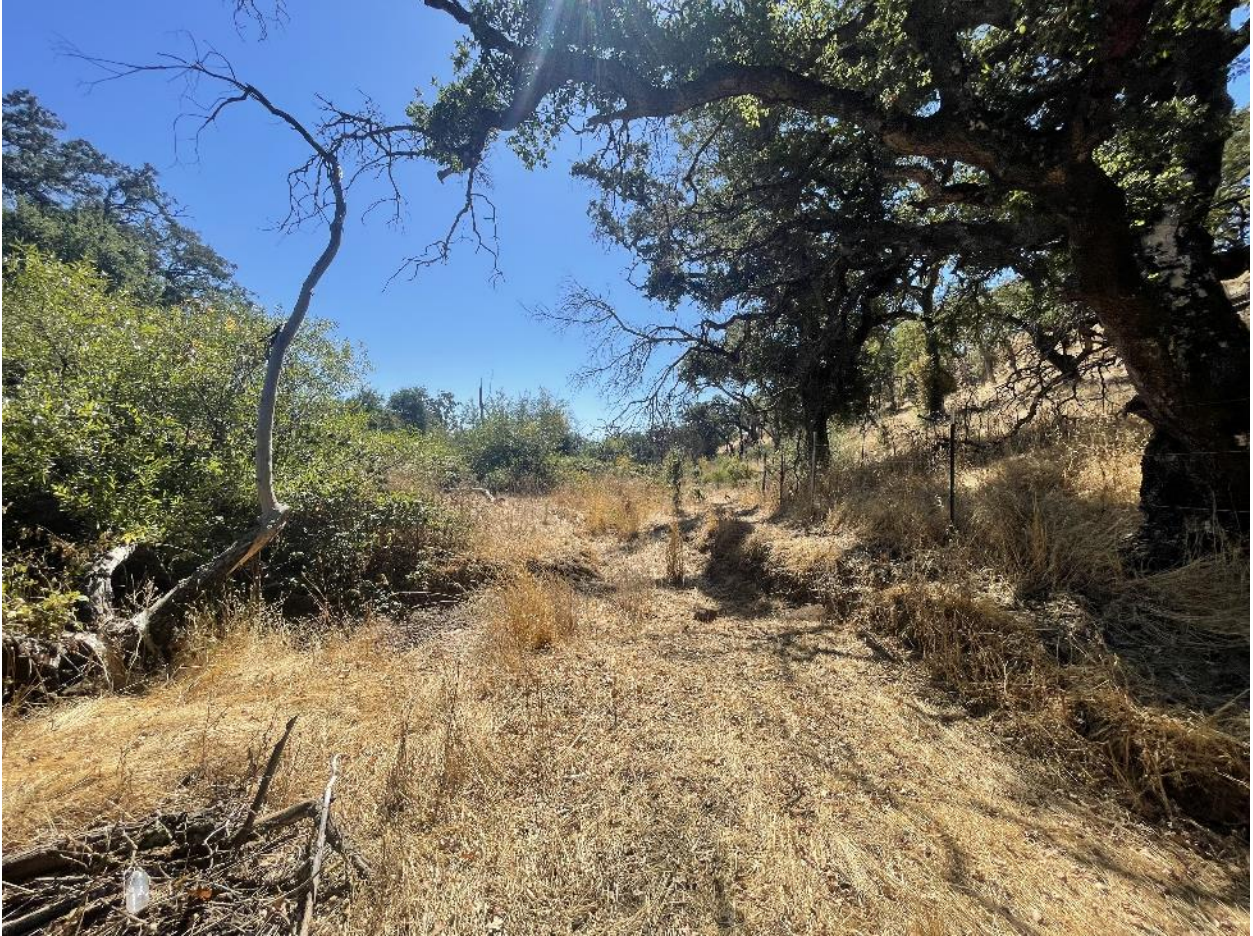
Figure 21: Water Retention Opportunity #6 BDAs and other water retention strategies could retain and recharge significant volumes of water in this low gradient section of Butler Creek.

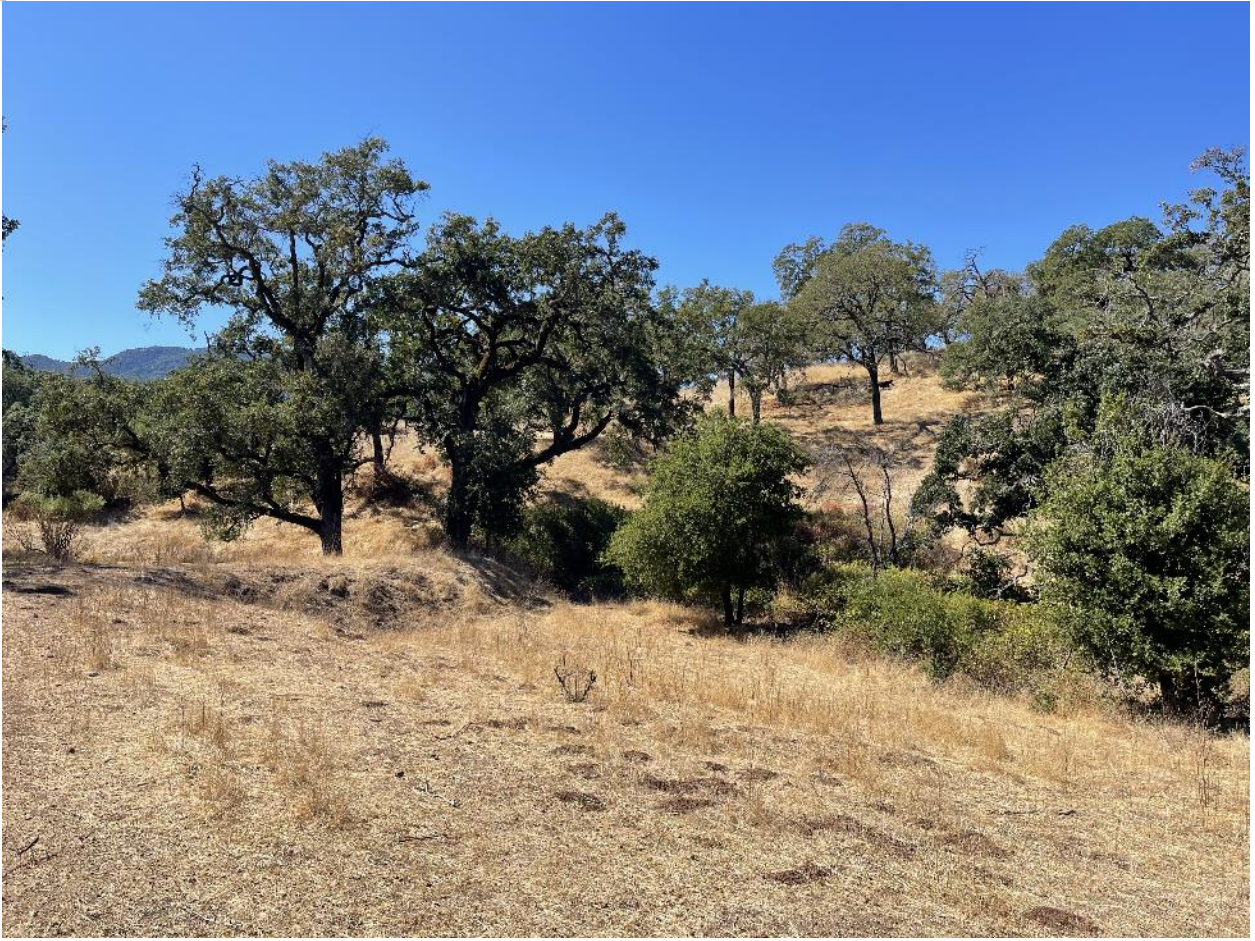
Figure 22. Section of Butler Creek in SDC showing a relic section of water detention berm.
