A Vision for Water Resource Management and Climate Resilience within the Open Spaces of the Sonoma Developmental Center (SDC)

October 2023

Prepared by Steven Lee and Jack Hines, Sonoma Ecology Center Research Program

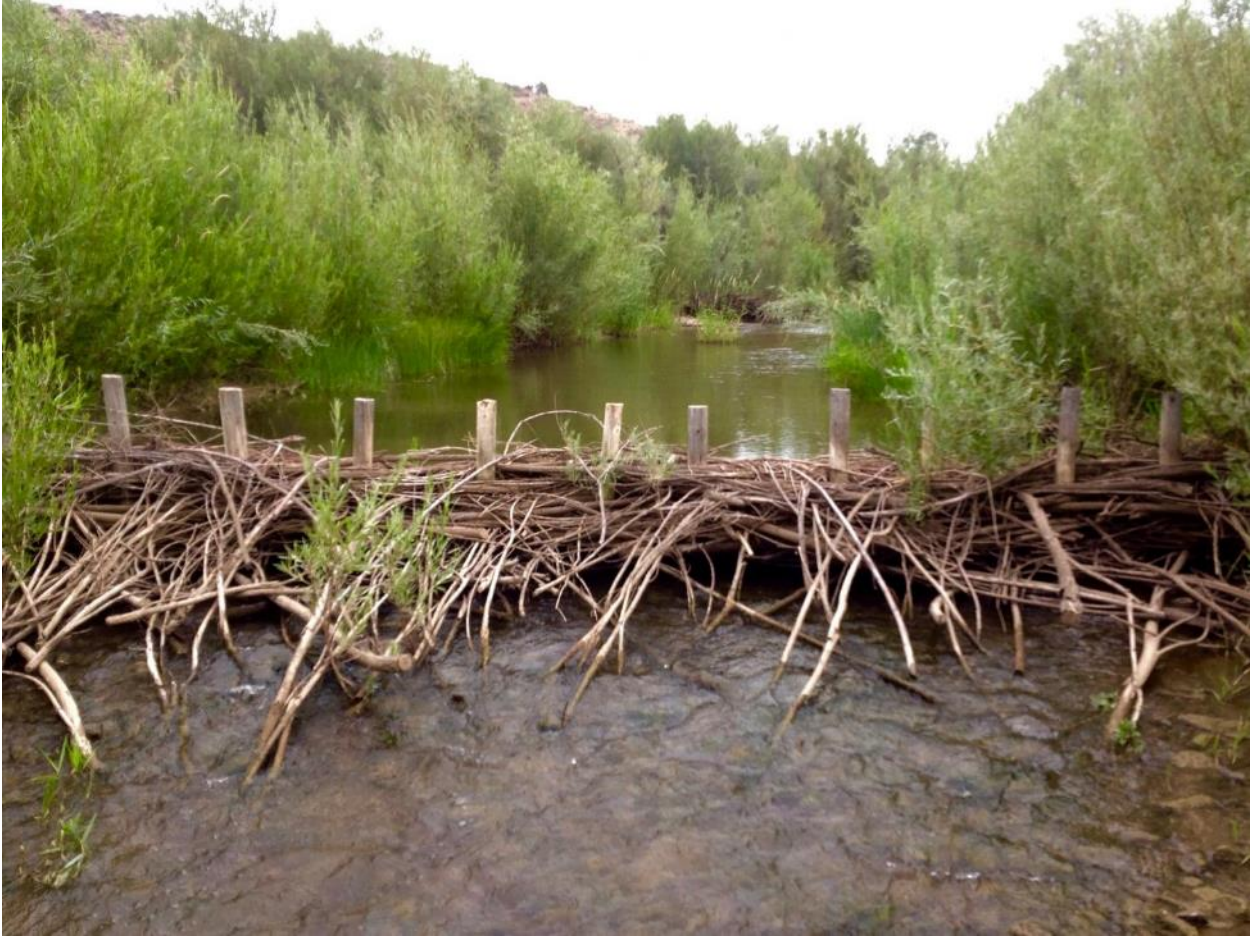
Figure 24: Example of Beaver Dam Analog (BDA) allowing for water retention in a low slope drainage area..

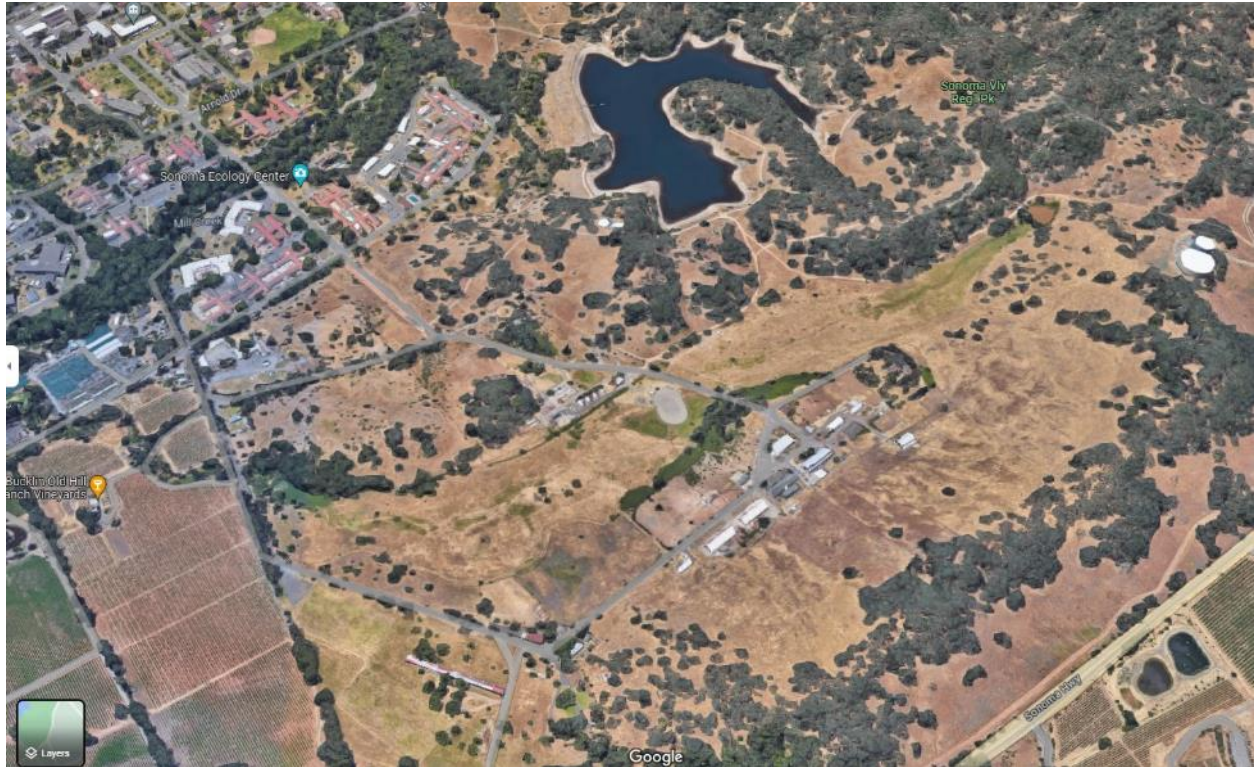
Also east of Sonoma Creek and the SDC redevelopment footprint lies the former institutional farm area (Figure 25) within which, due to the successful lobbying efforts of SEC and other associated entities, extensive wetland restoration is already being envisioned as part of the redevelopment process. Several opportunities for cascading water retention and wetland restoration features exist in this area beginning at an old farm impoundment (frog pond) which occurs at the north end of the drainage valley (Figure 26). With an estimated 400 acre feet of rainfall reaching this drainage area annually, huge bang-for-buck water retention and groundwater replenishment benefits are possible in this key watershed location (see recharge potential map in Figure 7). We suggest aiming as high as possible in this regard. This would begin at a re-engineered and enlarged impoundment at the north end, and continue with multiple detention or retention zones between there and the property line to the south (see Figures 27, 28 and 29). Such a plan could include opportunities for additional water inputs to this area beyond direct rainfall. There has been discussion that as part of the SDC redevelopment process, and notably consistent with the goals of a climate adaptation center envisioned for the site, a secondary wastewater treatment facility should be developed at the site, perhaps at the location of the old SDC Junior Farm. This would be a positive development for the Valley since the current sanitary system is already suffering from capacity issues and its location at the lower end of the valley is less suitable for reuse of recycled water. Should a secondary facility be installed onsite, dry season feeding of recycled water into the restored wetland complex would be favorable for both wetland function, ground water replenishment and post-wetland streamflow inputs to Sonoma Creek. Second, relocating the overflow spillway of Lake Suttonfield to the eastern side of the lake would allow another wet season input of water into this restored wetland complex and would also eliminate the channel downcutting and sediment inputs to Sonoma Creek which are occurring along its current drainage course (but see Opportunity #8). Third, Sonoma Water has been looking for opportunities for groundwater injection or infiltration as part of the Sonoma Valley Groundwater Sustainability Plan. The large storage tanks for the Sonoma Valley aqueduct occur on a hilltop just above the north end of this drainage area, so the opportunity for aqueduct inputs into this zone for groundwater injection or infiltration are present. This sort of water resource planning for the former agricultural part of the SDC land is wholly consistent with concepts for sustainable agriculture also being envisioned for this portion of the property. Wetland restoration and other water resource development would occur on the lower portions of this valley area while sustainable agriculture could occur at higher ground around the perimeter and

Figure 25: Water Retention Opportunity #7 Wetland restoration at the SDC farm area. View is facing northwest with Lake Suttonfield visible to the west of the old SDC farm area. Frog pond impoundment is visible at north end.

elsewhere. Agricultural sectors would have to be carefully sited in order to maintain adequate corridor connectivity toward Audubon Canyon Ranch to the north (where better crossing development over or under Hwy 12 is warranted) and the Butler Creek corridor to the south where existing culvert undercrossings should be widened.

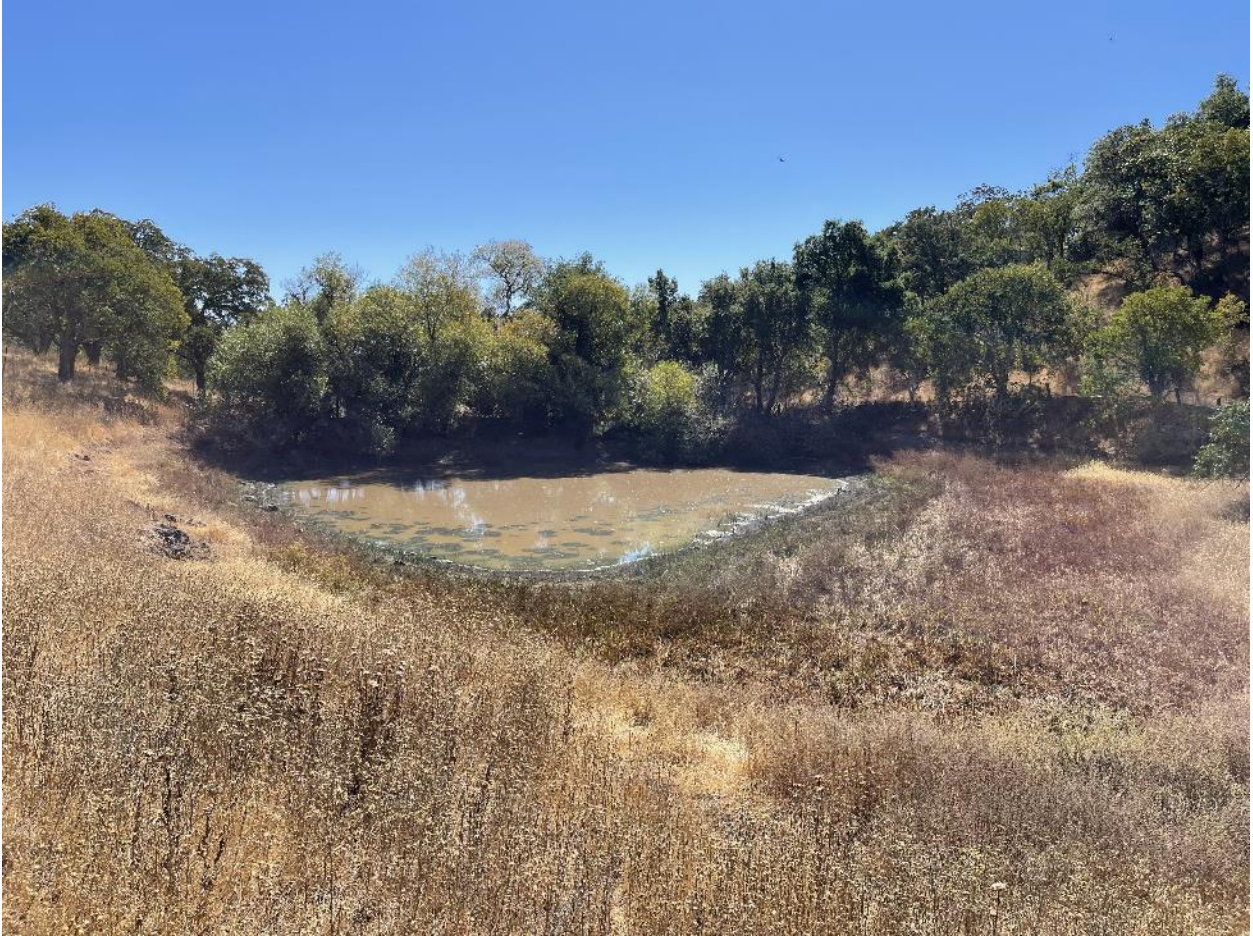
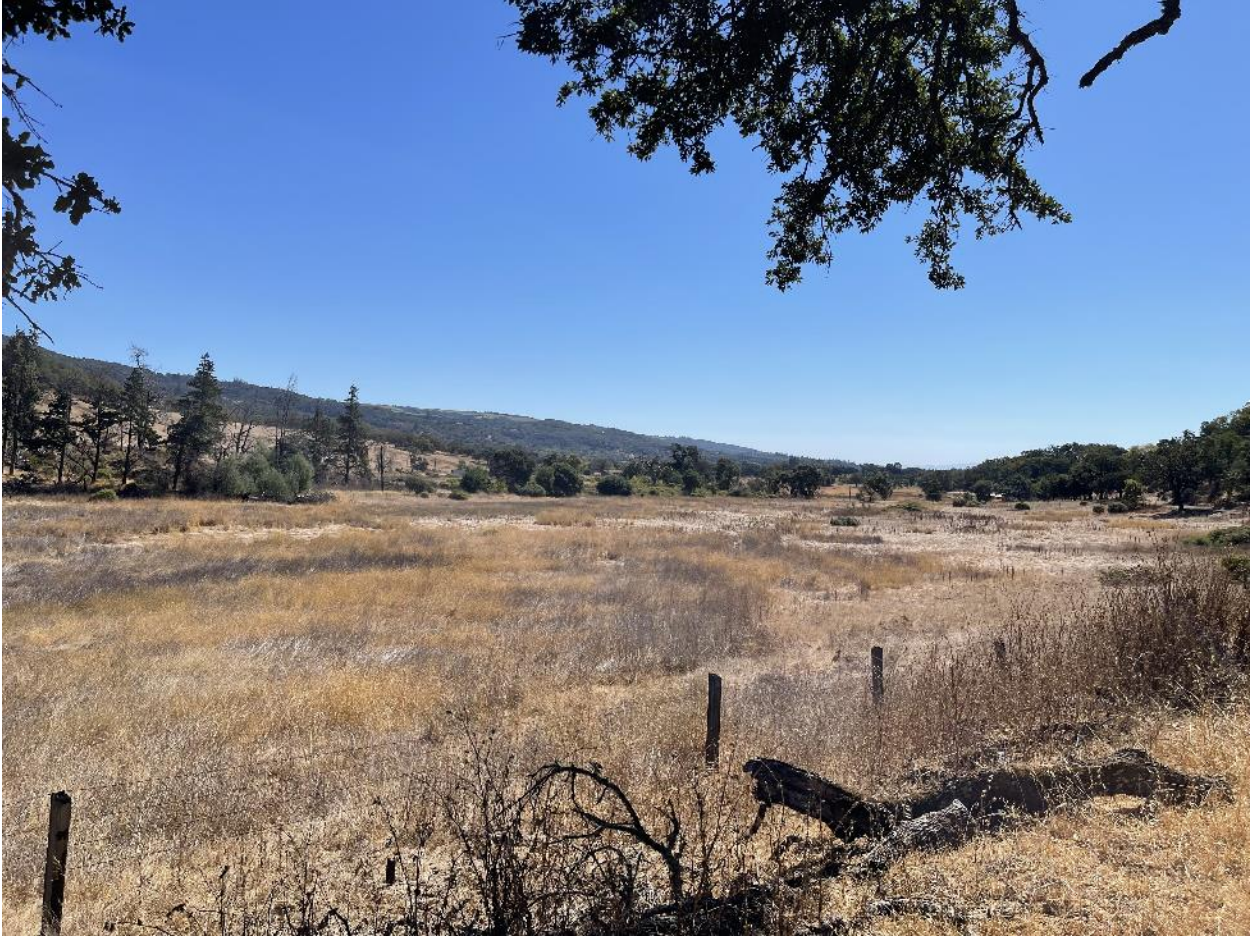
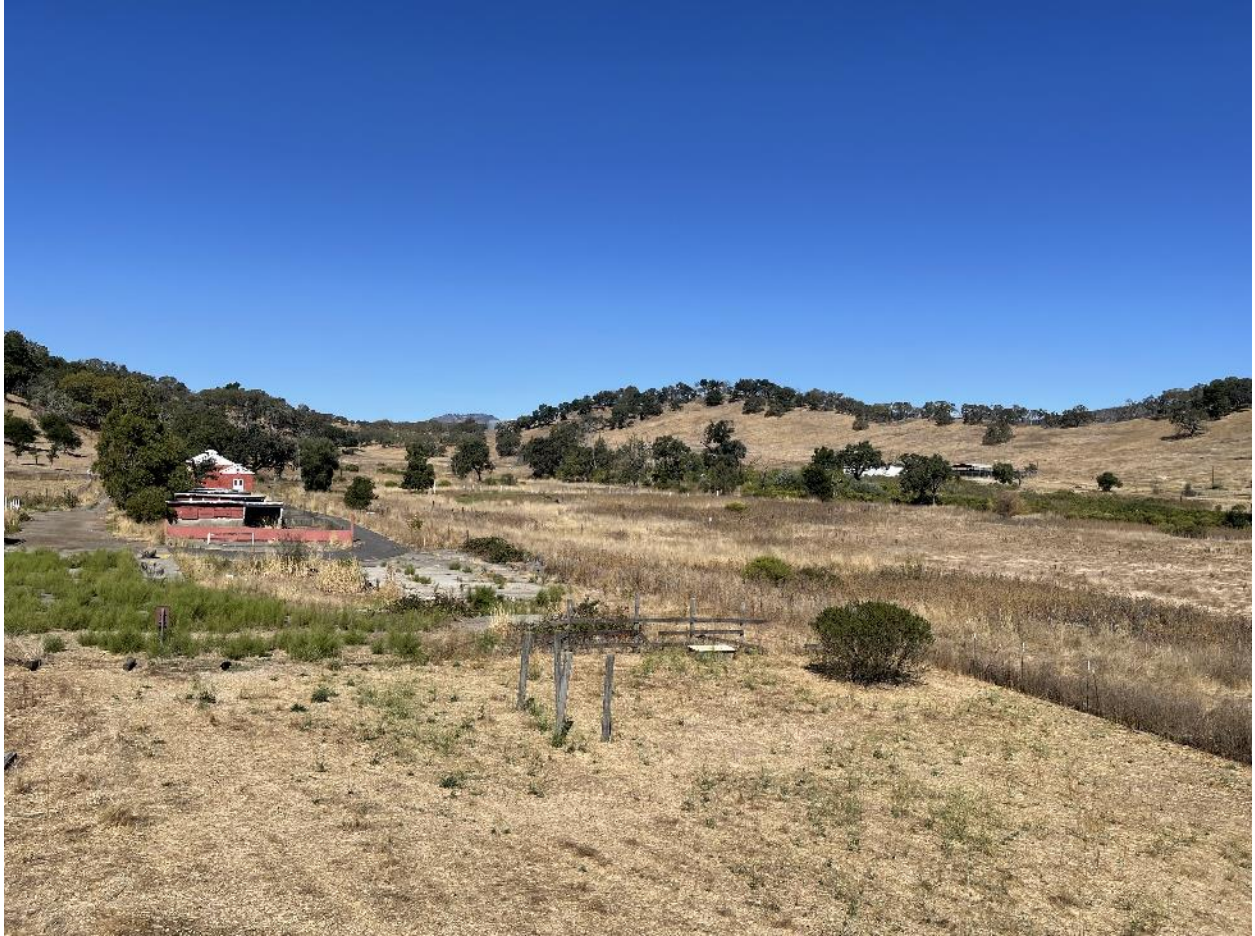
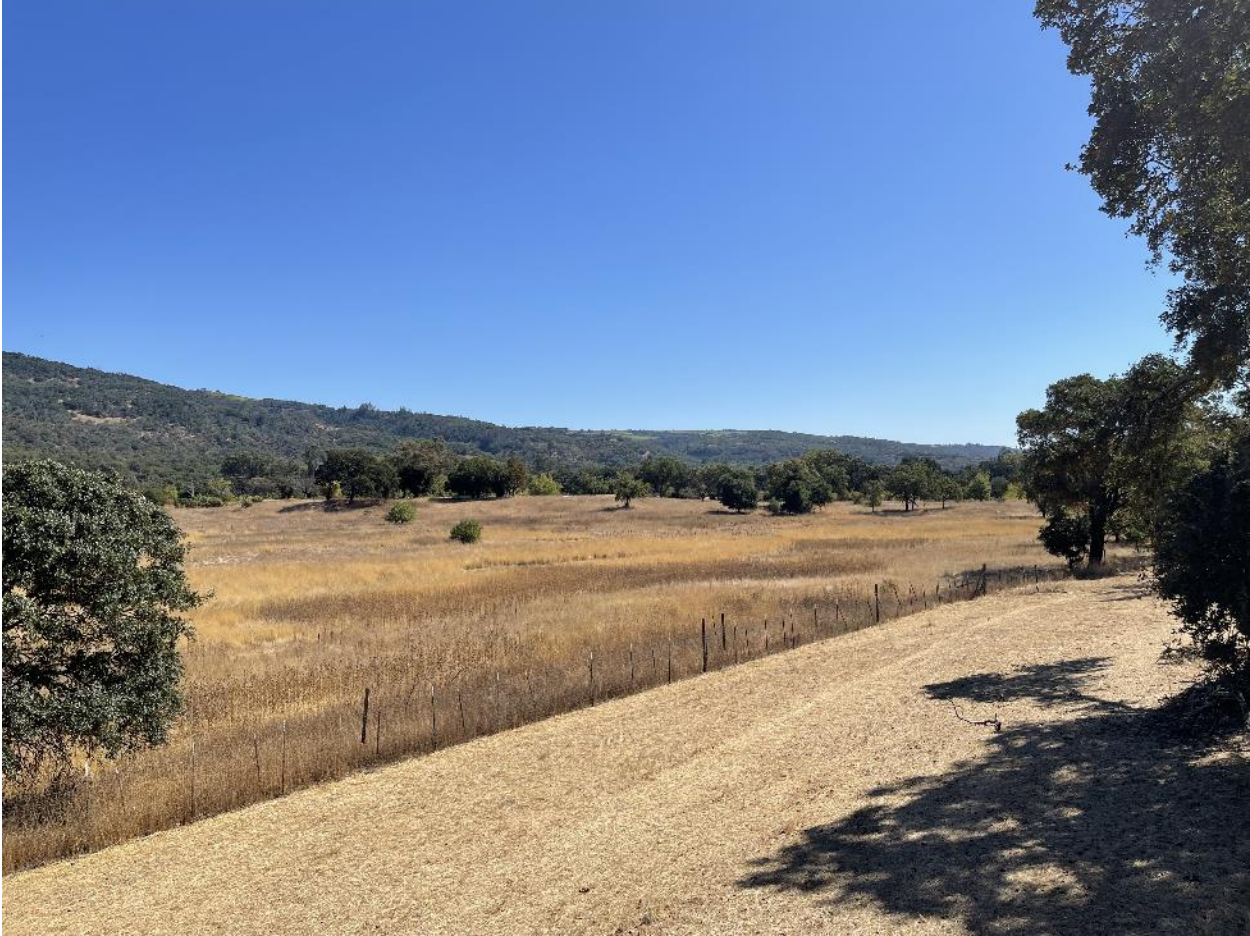
Figure 26: Water Retention Opportunity #7 Wetland restoration at the SDC farm area. View of the frog pond impoundment area, facing south.

Figure 27: Water Retention Opportunity #7 Wetland restoration at the SDC farm area. Shown here is the view facing south from below the frog pond impoundment.

Figure 28. Water Retention Opportunity #7 Wetland restoration at the SDC farm area. Shown here is the view facing north from below (south) of the old Junior Farm site.

Figure 29. Water Retention Opportunity #7 Wetland restoration at the SDC farm area. Shown here is the view facing south from the old Junior Farm area.

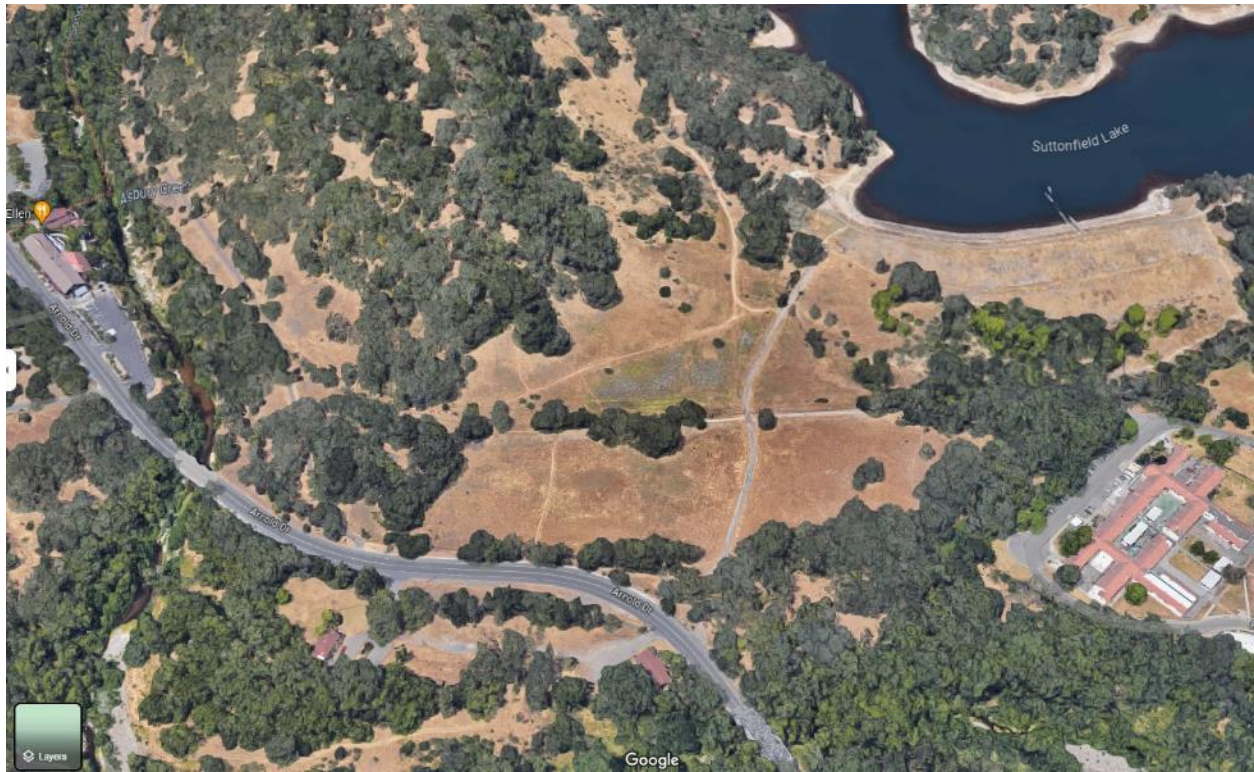
In the area east of Arnold Drive, between there and the dam for Lake Suttonfield (Figure 30), exist two relic railroad berms which interrupt the drainage pathways within this gently sloping area (see Figures 31 and 32). Currently, culvert undercrossings through these berm areas allow rainwater to concentrate and rush to Sonoma Creek during storm events. Erosion and sediment inputs to Sonoma Creek are occurring here because of these erosive channels combined with a chronic erosion site on the adjoining hillside (see Chronic Erosion Site #8 below in document) and improper drainage along the lake access road which has been spilling out onto Arnold drive until a recent, SEC -initiated repair job addressed the issue temporarily. The overflow spillway for Lake Suttonfield also occurs uphill from this site but its drainage channel bends around to the south where it joins its historical tributary flow pathway along the north edge of the developed campus. This is another favorable area for stormwater retention and groundwater infiltration. Through modifications to the berm culvert undercrossing points combined with moderate regrading of these meadow areas to create slight retention “bowls,” and by redirecting Lake Suttonfield overflow water into this area (should the related aspect of Opportunity #7 be deemed undesirable), significant water retention could occur in this area. Post-construction, such retention zones would exist without any fundamental, negative aspects to wildlife habitat values including the corridor functions. In fact, having more diverse habitat within these areas which are nearly 100% grassland presently, would improve said habitat values. An even better scenario would be to improve wildlife connectivity either under or over Arnold Drive at this location. While the undercrossing at the downstream bridge (Berkland Bridge) is heavily used by wildlife, crossings over this section of Arnold Drive are very common as well. As this is the most critical pinch point of the wildlife corridor, and because the presence of this corridor was the primary justification for protecting these open space areas, development of a safe crossing point for animals at this location would seem worthy of consideration. Such projects would change some of the access pathways for visitors to the Sonoma Valley Regional Park who currently park there on the Arnold Drive road shoulder. But because this is the most critical section of the wildlife corridor, this parking and access

Figure 30: Water Retention Opportunity #8 Water retention berms between Arnold Drive and Lake Suttonfield dam.

point should be discouraged anyway in favor of a formal parking and access point within the redeveloped campus at the end of the old railroad pathway.

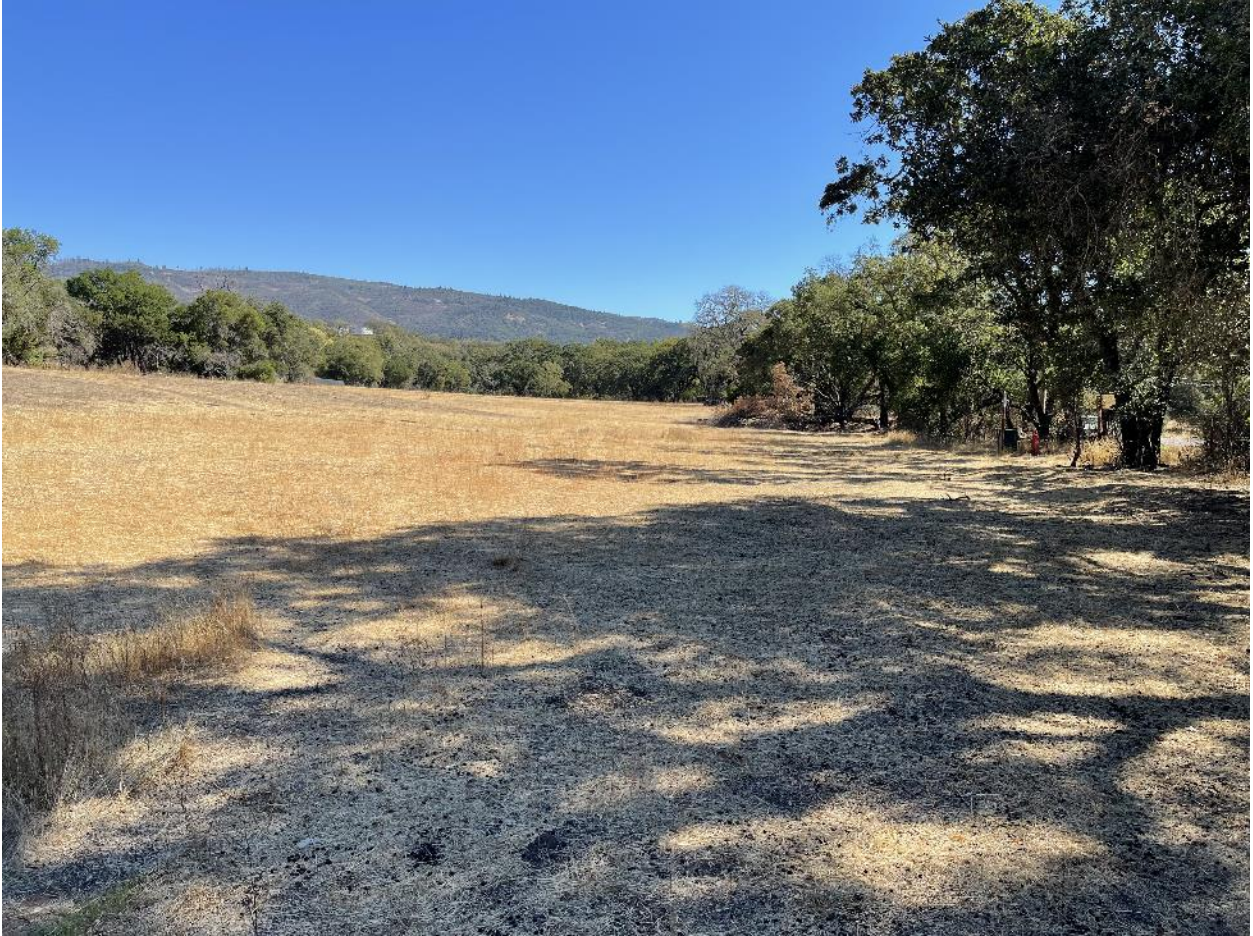
Figure 31: Water Retention Opportunity #8 Potential water retention zone above Arnold Drive and the old North West Pacific Railroad Berm.

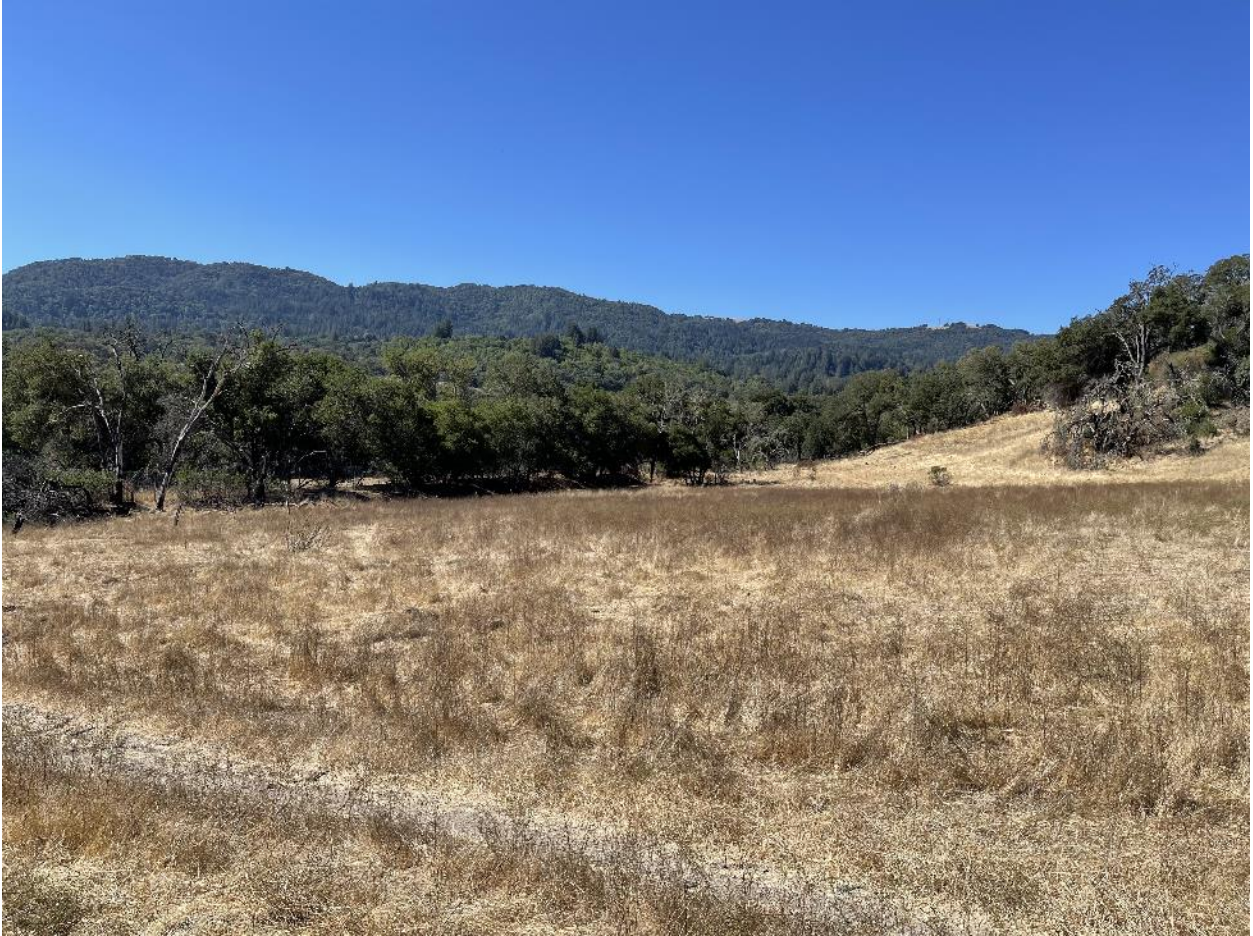
Figure 32: Water Retention Opportunity #8, Potential water retention zone further upslope above old Southern Pacific Railroad berm.

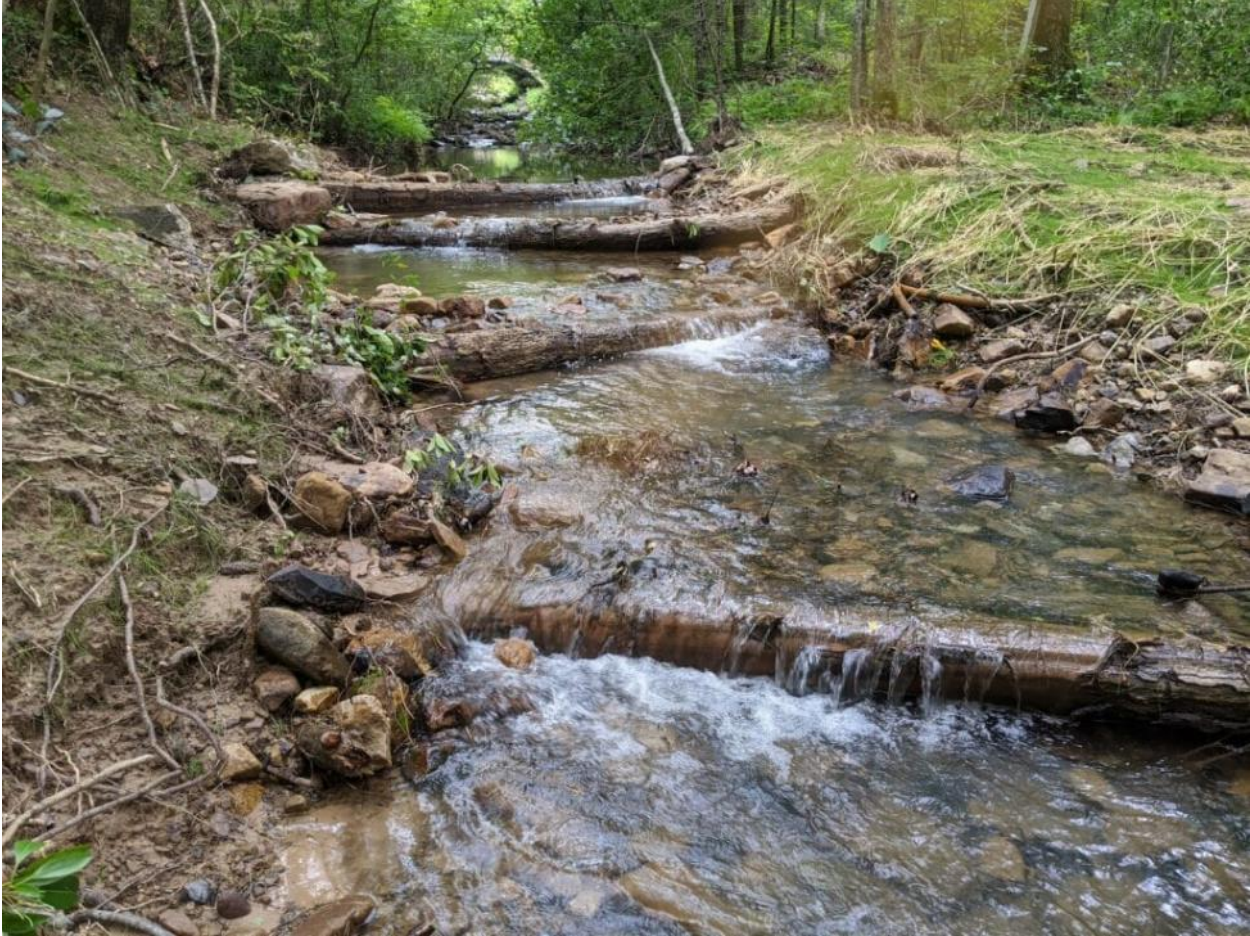
Up in the Mattole and other watersheds, innovative water retention approaches are being taken to replenish groundwater levels and improve dry season flows in salmonid rearing streams. One such approach is to construct moderately sized retention basins in strategic locations proximate to stream corridors and allow retained water to slowly leak to the stream into the dry season. Another is to apply stage zero approaches such as inserting large wood elements bank-to-bank in narrow, v-shaped stream courses where the gradient is less than 2-2.5% slope. By setting such tree sections at existing grade, embedding them into the banks and then backfilling with a mixture of fine streambed materials and bentonite, an aquatard is produced which allows for bed aggradation, slow-release water retention and resulting rising of the water table (Figure 33). Natural features just like this are elements found frequently in healthy creeks. Trees employed in this way are sized according to the characteristics of the channel such that they don't become potential barriers to spawning fish. Generally, a scour pool develops just downstream of these structures which creates resting habitat during upstream migration during the wet season as well as rearing habitat during the dry season. SEC has done an analysis of both Asbury and Hill Creeks and has identified a suite of locations (yellow segments in Figure 34) of appropriate gradient for this approach. Further study would be required to fully vet these sites, but we already know several of these locations to be particularly suitable (e.g., the section of Asbury Creek upstream of the Roulette Creek confluence).

Figure 33: Water Retention Opportunity #9, Example of “Stage Zero” creek restoration involving large wood “aquatard” structures embedded into the stream banks.

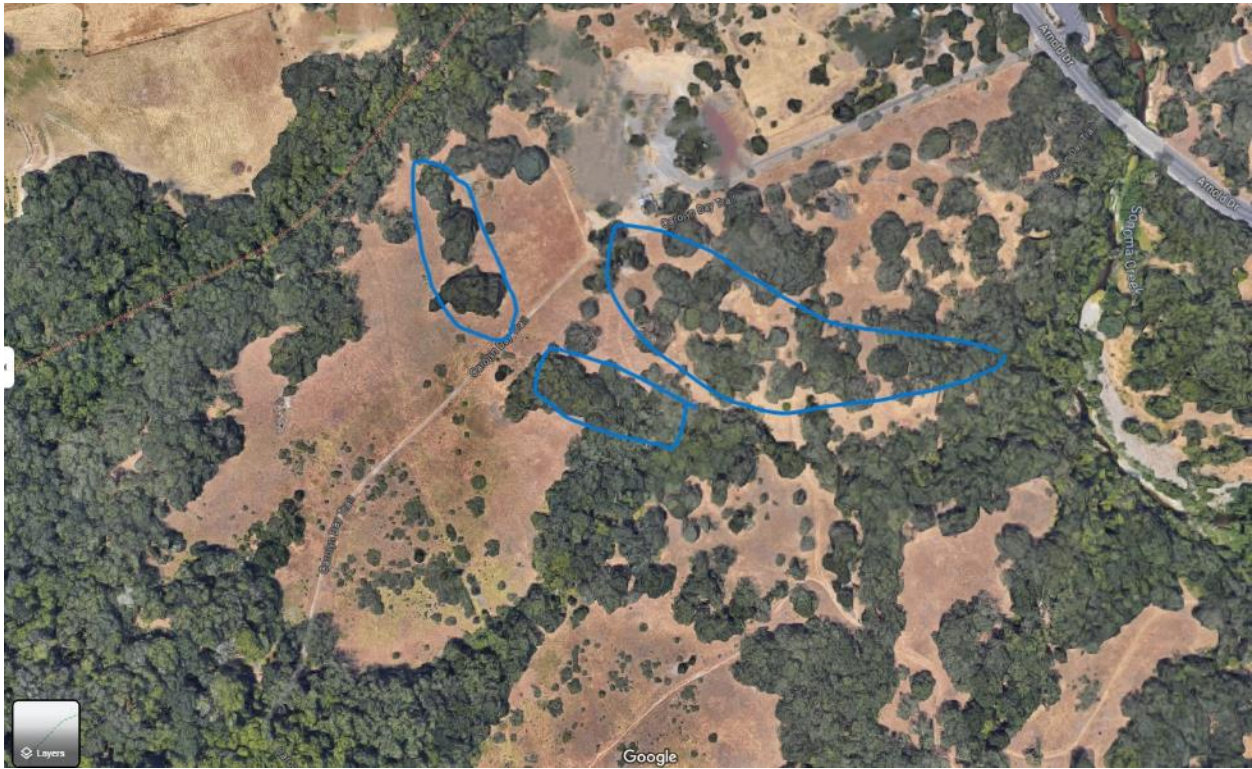
Throughout the SDC open space, small draws and gullies occur (see example sites in Figure 35) where actions could be taken to slow down the transference of gathering storm flows to the creek during storm peaks, reduce some of the entrainment of sediments which takes place in these areas, and allow some of that retained water to percolate into the ground, while improving habitat values at the same time. One of the draws depicted here has been headcutting in recent years. Process based restoration actions such as BDA installations, large wood check dams and packing of smaller gullies and draws with forest thinning slash can all serve to retain water and help to rehydrate the landscape (see: <https://oaec.org/forest->

Figure 35. Water Retention Opportunity #10, Example gently sloped draws on SDC western open space where BDA and/or gully packing approaches could be implemented.

thinning-and-gully-repair/). Figures 36 and 37 show different views of one such draw we are particularly familiar with which has a favorable gradient and configuration for such strategies to be appropriate. We highly recommend pursuing strategies like this throughout the property, and especially doing so in association with fire fuels management work which generates lots of slash to be made available for gully packing.

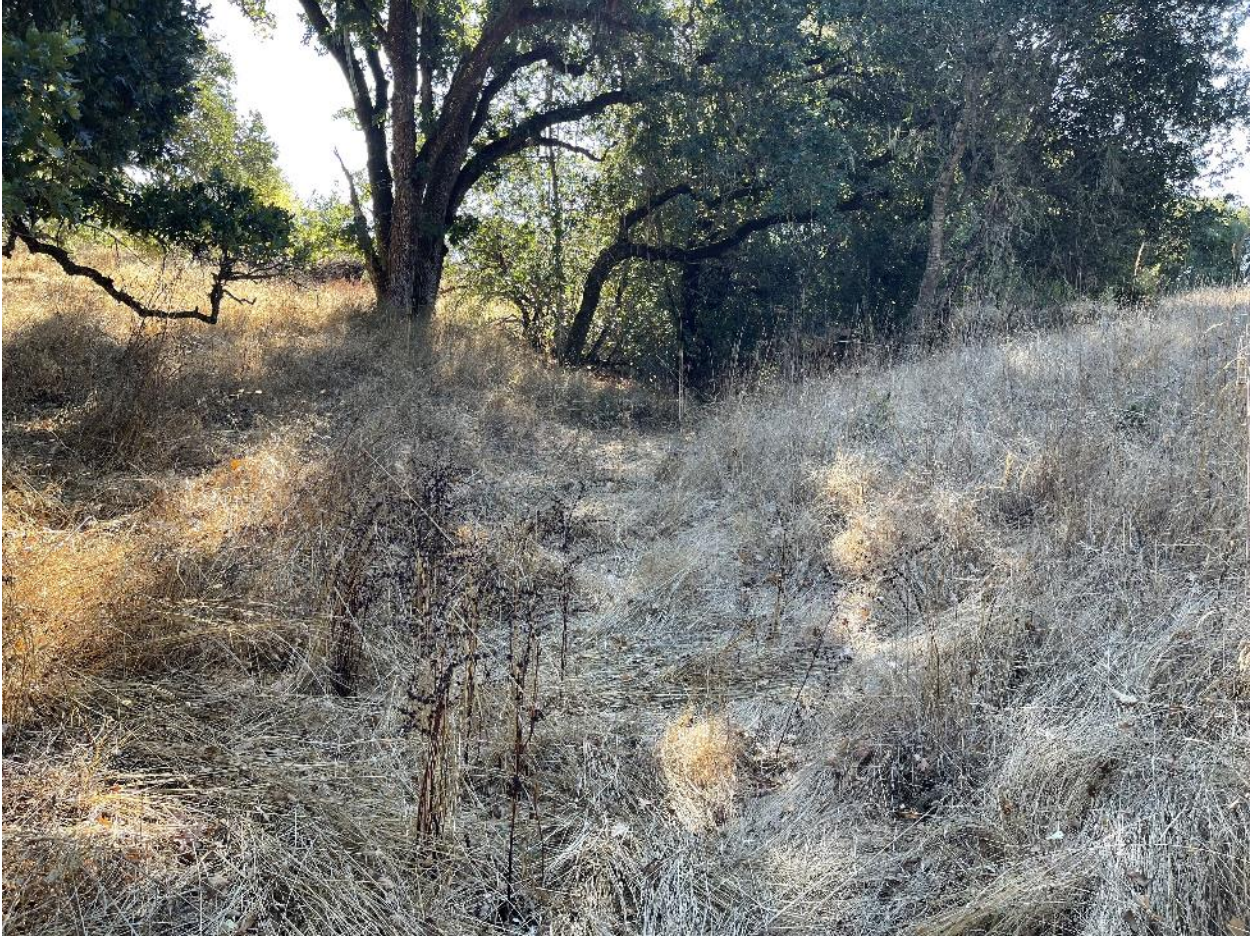
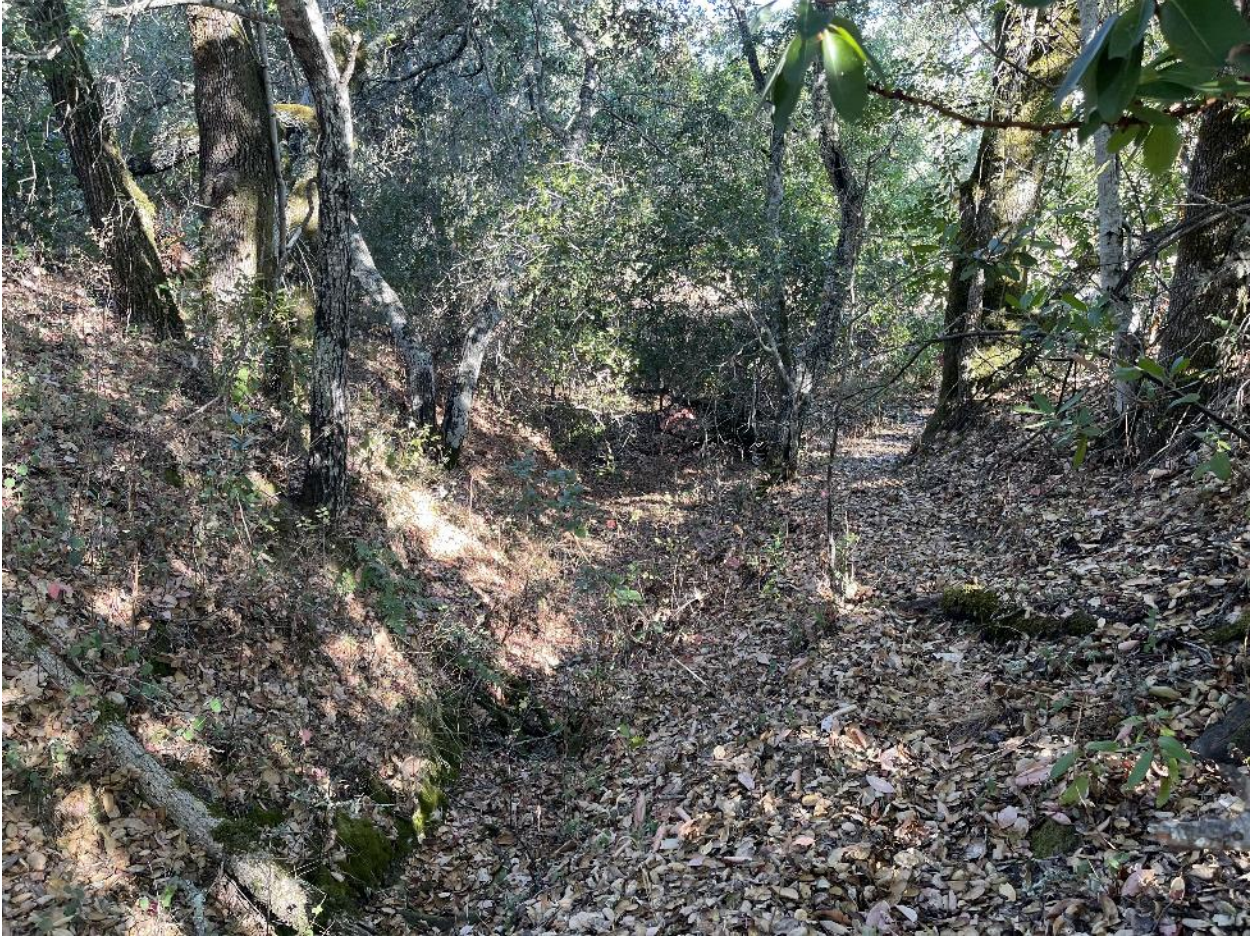
Figure 36. Water Retention Opportunity #10, Example of a gently sloped draw on SDC western open space where BDA approach could be implemented.

Figure 37. Water Retention Opportunity #10, Example of a gently sloped draw on SDC western open space where BDA and/or gully packing approaches could be implemented.

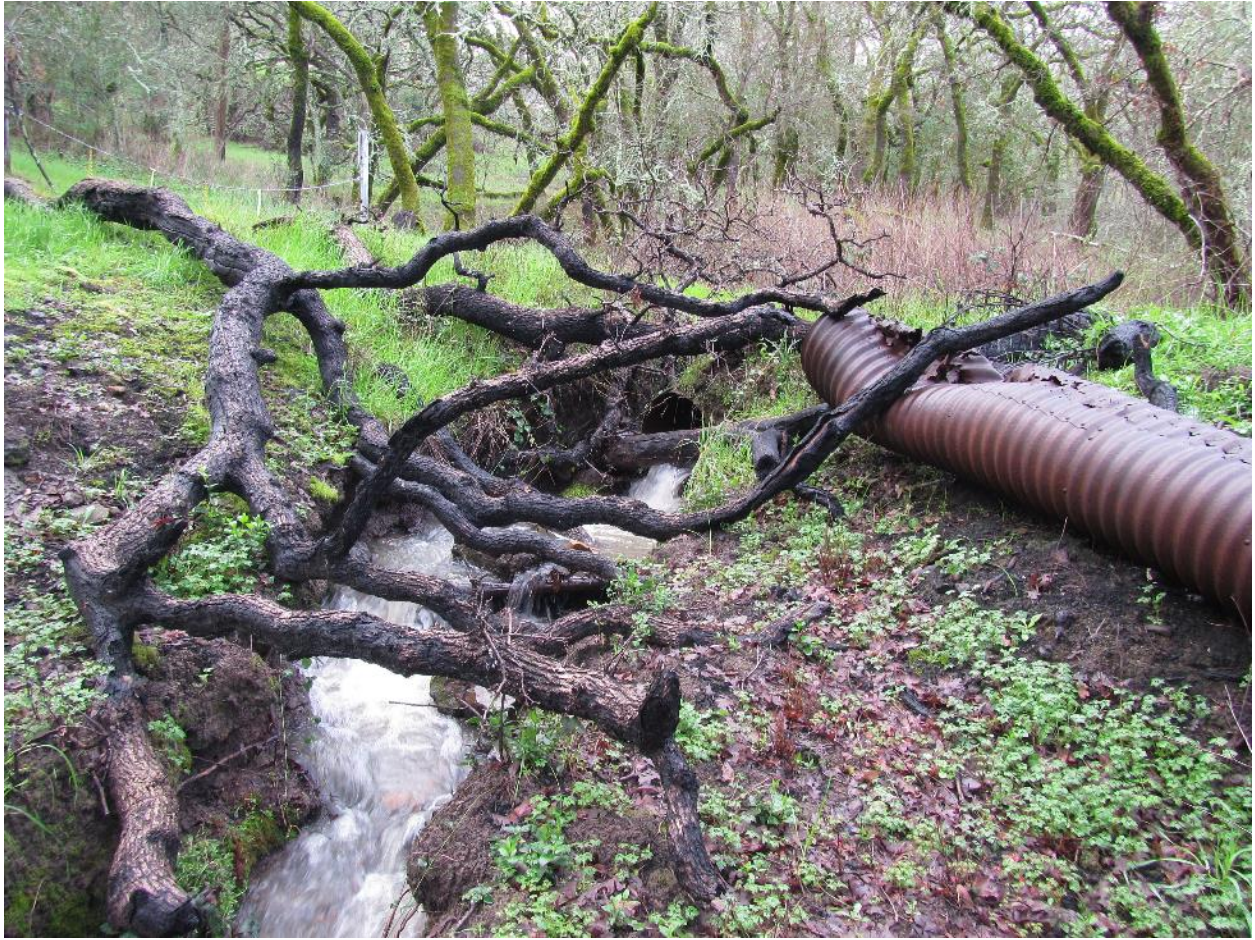
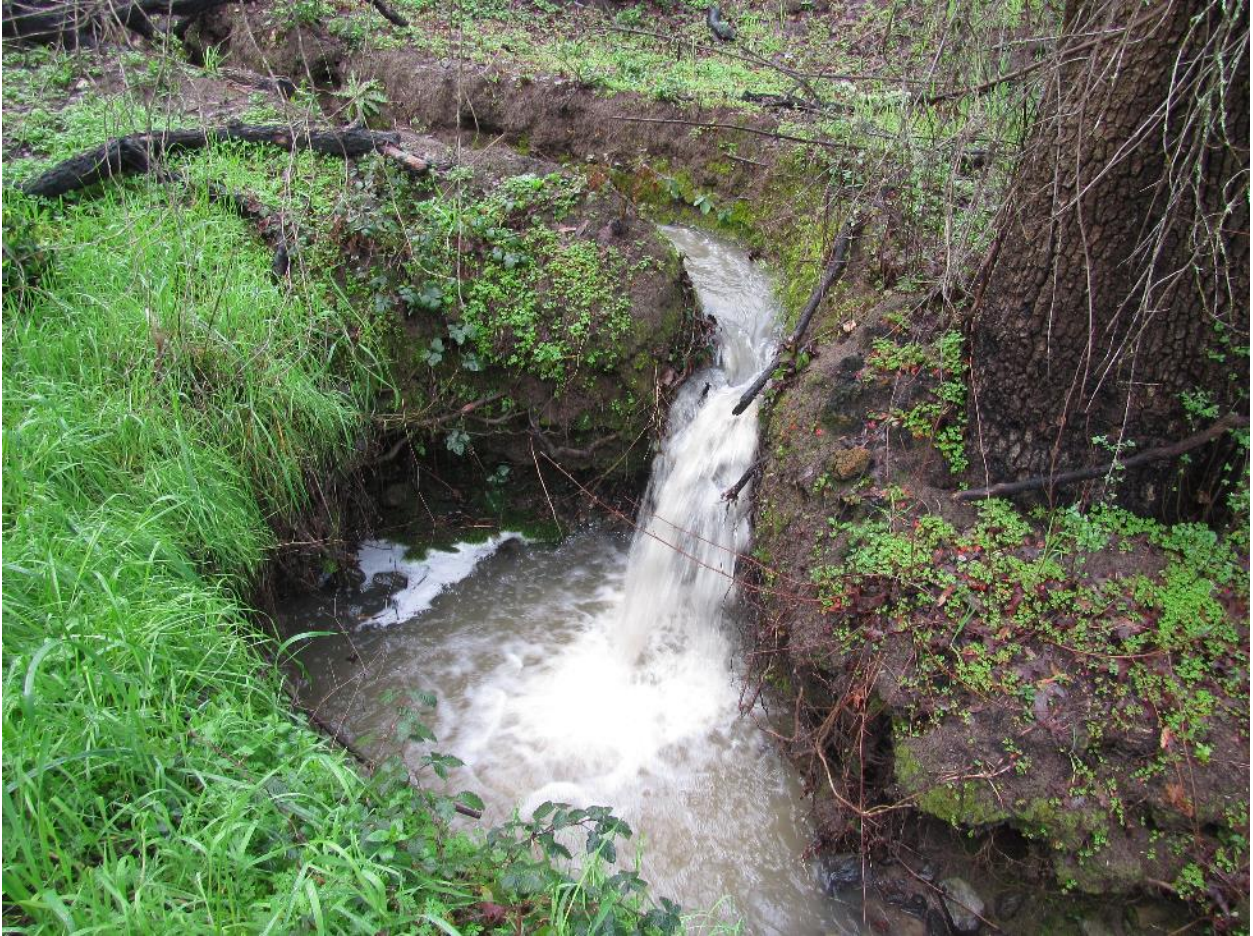
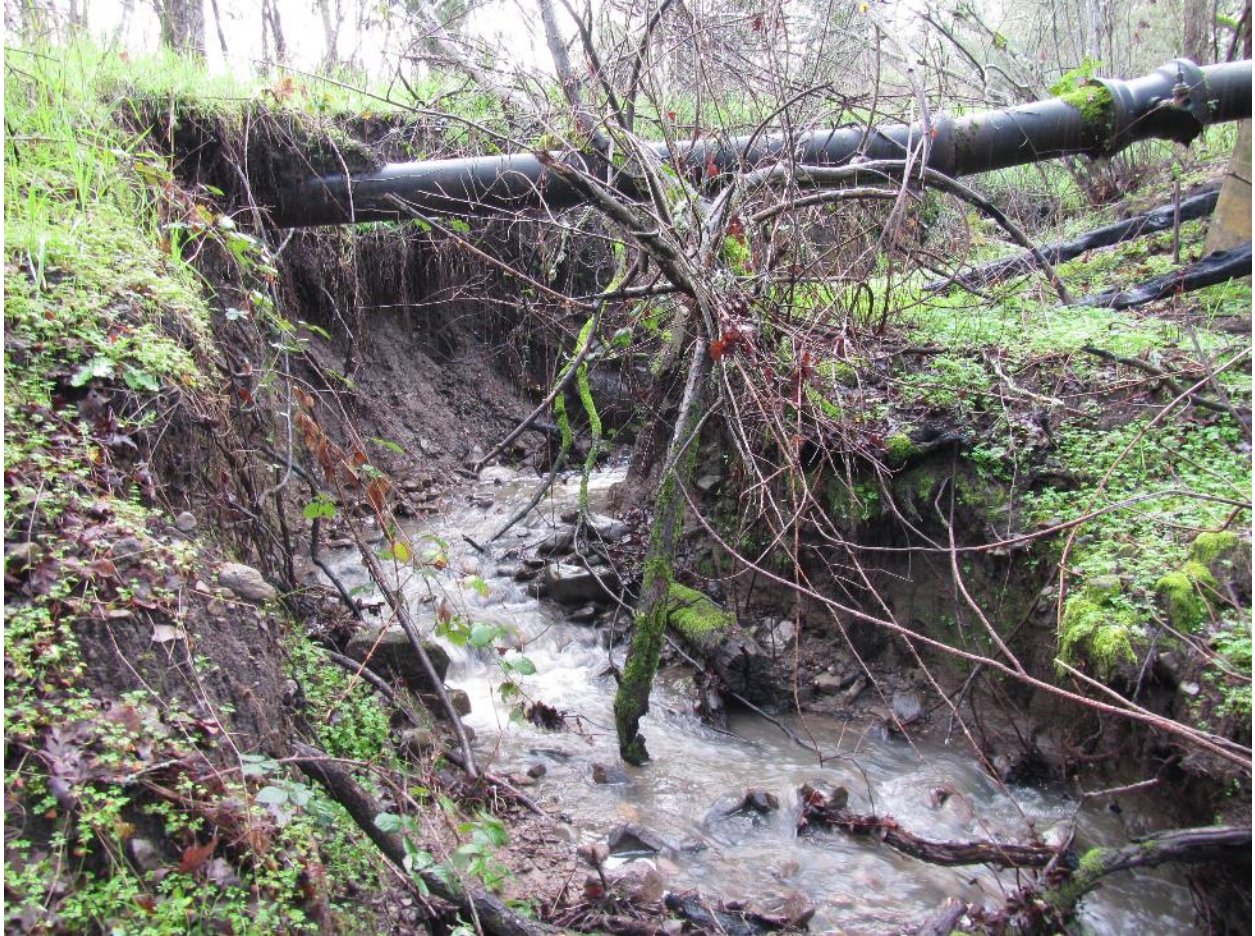
Early in the SCC project a map of SDC's stormwater system was studied, and then reconnaissance occurred along the entire ~1 mile reach of Sonoma Creek to physically locate and assess every drainage culvert daylighting within the creek's riparian zone. Opportunistically, the reconnaissance work was done in the midst of a significant, February 2019 storm event when outflows were near their 10-year peaks. This allowed us to

Figure 38: Chronic Erosion Site #1, Culvert-related gully erosion just north of developed campus at bottom of Corridor Creek South.

Figure 39: Chronic Erosion Site #1, Headcut and beginning of severe gully formation at lower Corridor Creek South.

Figure 40: Chronic Erosion Site #1 Extensive culvert-related gully formation at lower Corridor Creek South. A large diameter conveyance pipeline connecting Fern Lake and Lake Suttonfield is threatened with breach at this location.

understand, without hydrological analysis, the erosive potential of these outflows, and hence prioritize which culverts at SDC were in the greatest need and best suited for remediation and restoration using our SCC project funds. Since our project work plan mandated habitat-related regulatory permitting and implementation involving hand tools (as compared to heavy equipment), several culvert sites had issues which were well beyond the scope of what we could address. One such site is a culvert-related erosion gully which exists just north of the developed campus at the downstream end of Corridor Creek South (see Chronic Erosion Site Ero #1 in Figure 4). At this location a primary fire service road crosses this drainage and just below the road crossing culvert (Figure 38) the drainage drops down through at least two worsening head cuts (Figure 39) into a deep, vertically sided arroyo-type erosion zone (Figure 40). Crossing this zone is the large diameter conveyance pipeline connecting Fern Lake and Lake Suttonfield via the pumping station. The buttress for the pipeline is losing its soil support and the pipeline is bowing downhill and showing signs of stress including a leak at a connection joint. Not only is this site contributing eroded sediment to Sonoma Creek, but this critical conveyance pipeline seems about to breach. Should that occur, even more sediment will find its way to the creek. The issues at this site were beyond the scope of what SEC's restoration team could address as part of this project. However, after seeking approval from the SCC grant manager, we did use project planning funds to hire an engineering consultancy and have them study the site and develop a conceptual design plan for how that site should be remediated. That design plan is included here in Appendix 3.
