A Vision for Water Resource Management and Climate Resilience within the Open Spaces of the Sonoma Developmental Center (SDC)

October 2023

Prepared by Steven Lee and Jack Hines, Sonoma Ecology Center Research Program

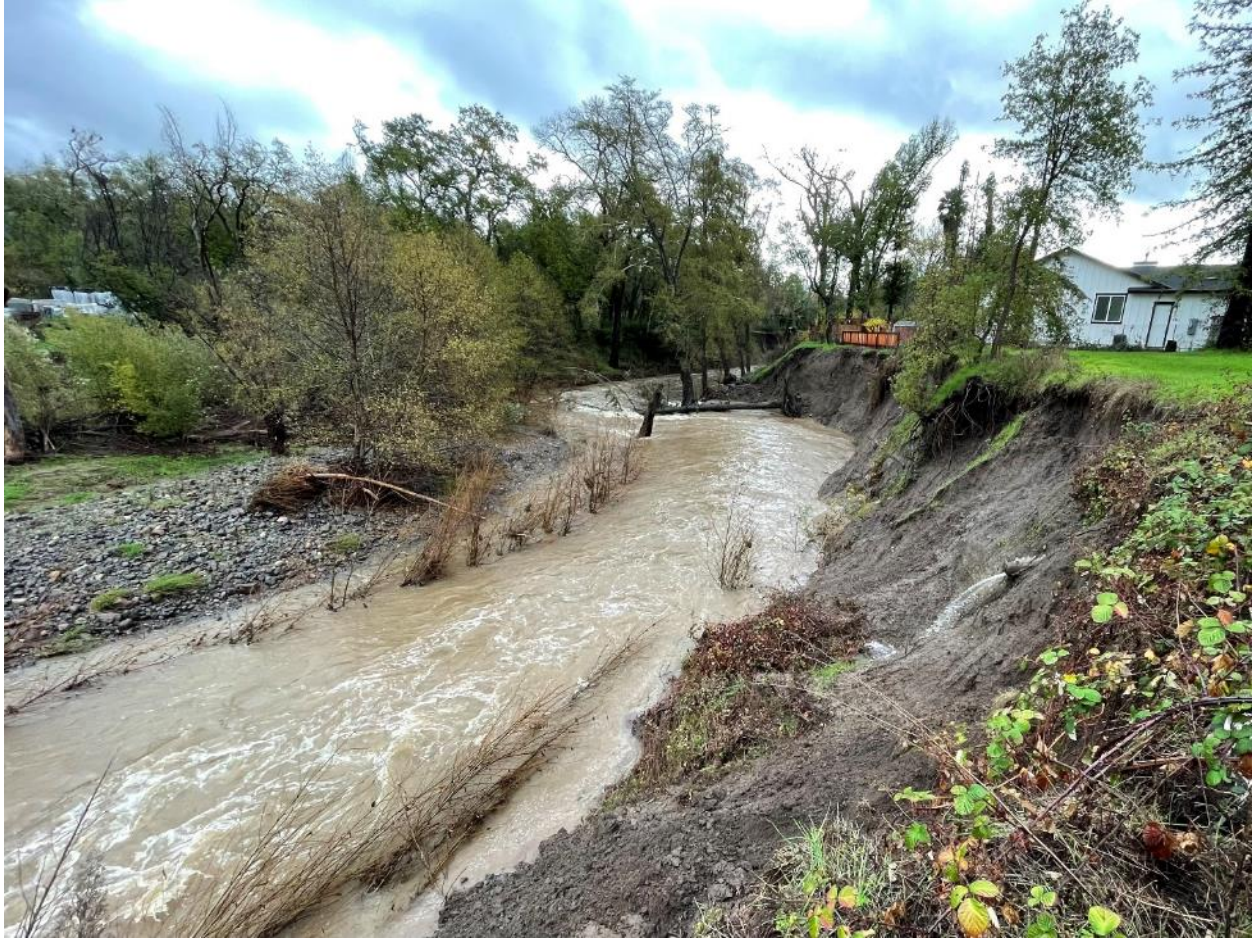
At the downstream end of the SDC reach of Sonoma Creek, adjacent to Redwood Drive near the Emparan building exists a massive bank failure that began on SDC property but has migrated downstream and is threatening a home on Burbank Drive in the adjacent community. Many years ago the main channel of Sonoma Creek was well to the east closer to the opposite bank of the creek. But in recent years the channel has migrated to the west eliminating an old relic floodplain that occurred there, and subsequently caused incision on the right bank to the point where it became nearly vertical. Two SDC culverts daylight in this area. Initially they emerged onto the relic floodplain as they do elsewhere at the facility, but as the bank retreated, sections of those pipes have fallen away with continuing stormflow cascading down the steepening banks, thus contributing to further erosion. Stormflow energy reflecting off this eroding bank has been deflecting to the opposite bank just downstream of SDC where it has caused a vertical incision problem of similar scale there. The situation in this area constitutes a massive chronic erosion site that will require

Figure 41: Chronic Erosion Site #2, Bank failure on Sonoma Creek at downstream end of SDC reach. Nearby house is threatened.

significant engineering efforts to address. As part of the SDC specific plan, setbacks of 100 feet are called for along the margins of Sonoma Creek. But in this portion of the redevelopment footprint, such setback considerations should not be based on the current margin of the creek corridor. Any redevelopment should remain well outside the needed restoration envelope for this site. SEC's Upper Sonoma Creek Restoration Vision (see <https://sonomaecologycenter.org/restoration-vision/>) should be consulted before any future creek setback decisions are solidified.

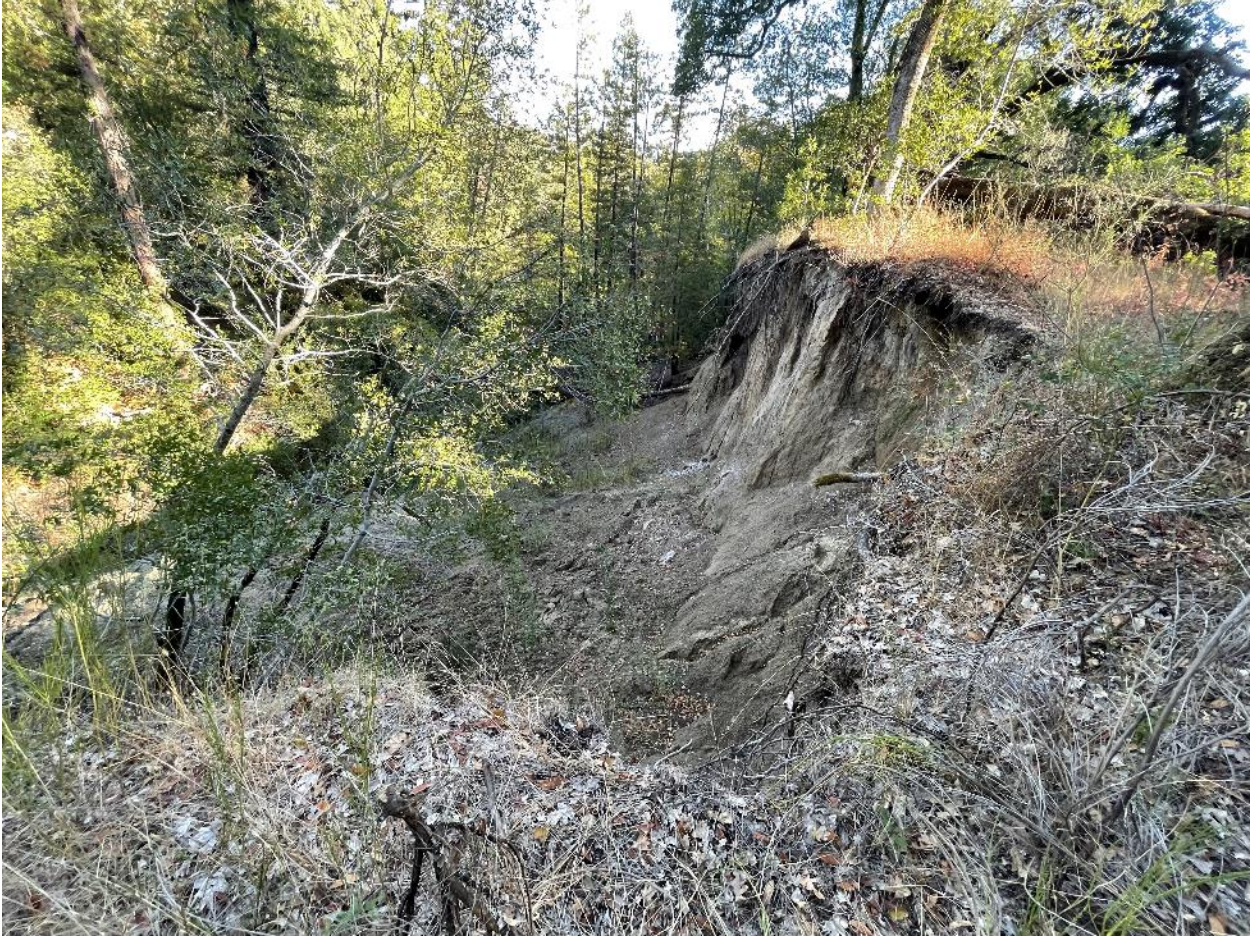
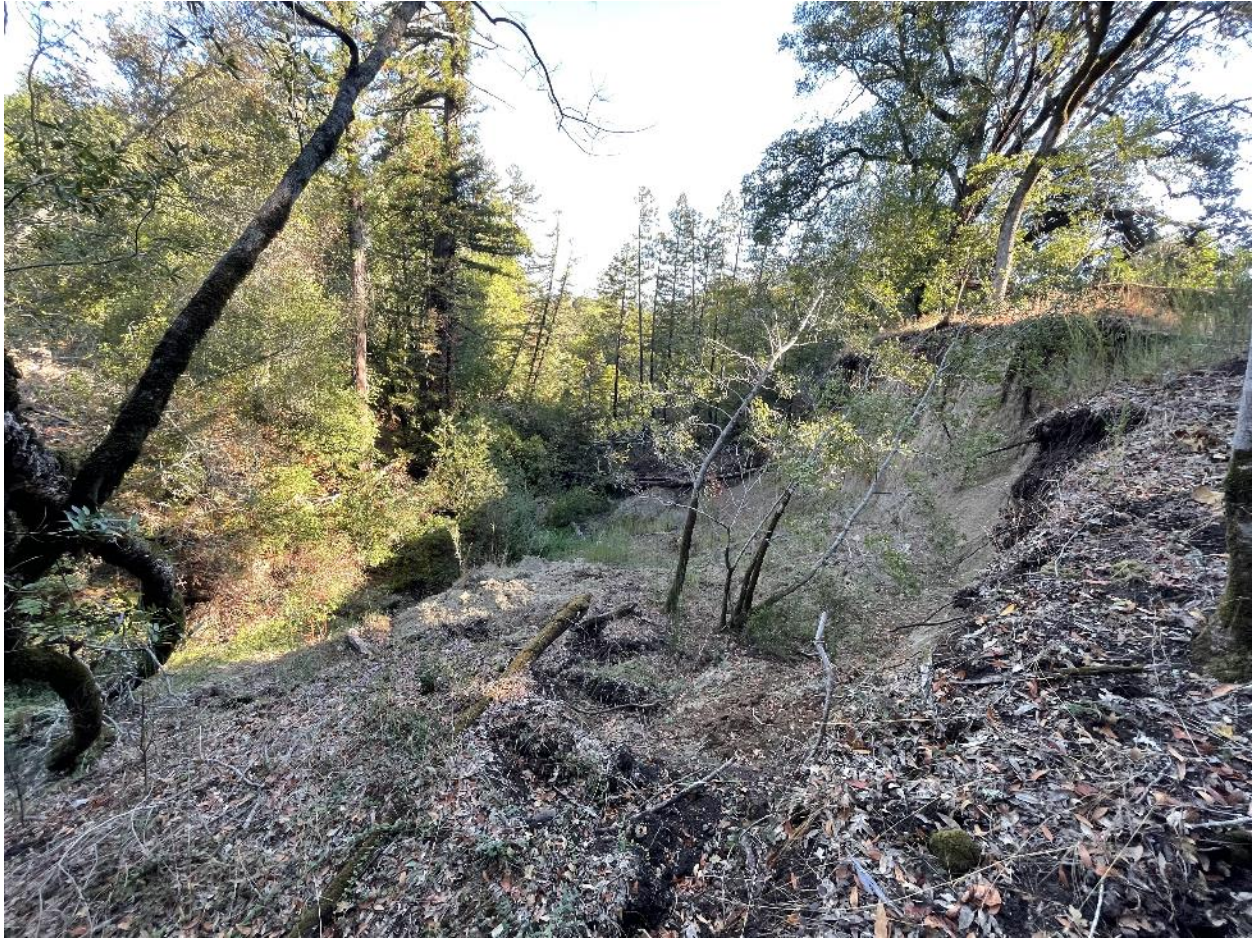
Land slides, historic and contemporary, are a common feature within the SDC open space, and Glen Ellen generally. The existence of Roulette Springs is the result of a historic landslide at the foot of which the spring is located. Further downhill, where Roulette Creek makes its confluence with Asbury Creek, a significant, contemporary slide exists which has been delivering quarry-scale amounts of fine sediments to Asbury Creek over the past decade or two. A fire service road used to dip down and cross Roulette Creek at this site, but the culvert under this road was washed out some time ago (probably the result of a debris jam), and the toe of the bank became destabilized leading ultimately to the situation seen in Figures 42 and 43. There are actually two individual slide escarpments in this area separated by a narrow ridge of apparently firmer material. Due in part to the presence of spring water outflows, but also because of the dense vegetative cover and afternoon sun angle, Asbury Creek, which used to be a steelhead bearing stream, has cool water temperatures throughout the dry season and is a viable candidate for fisheries restoration. However, much of the creek's streambed is laden with fine sediments due to this slide and other erosion issues described in this document. Young steelhead could successfully rear in Asbury Creek with these sediment accumulations present, but spawning is currently favorable only upstream of the Roulette Creek confluence. Finding a way to stabilize this slide area and prevent continued sloughing of fine sediments to Asbury Creek would be an important, if challenging, management goal for this property.

Figure 42: Chronic Erosion Site #3 at confluence of Roulette and Asbury Creeks. Quarry scale amounts of fine sediment have been eroding to Asbury and Sonoma Creeks from this location for the past two decades.

Figure 43: Chronic Erosion Site #3 at confluence of Roulette and Asbury Creeks. Quarry scale amounts of fine sediment have been eroding to Asbury and Sonoma Creeks from this location for the past two decades.

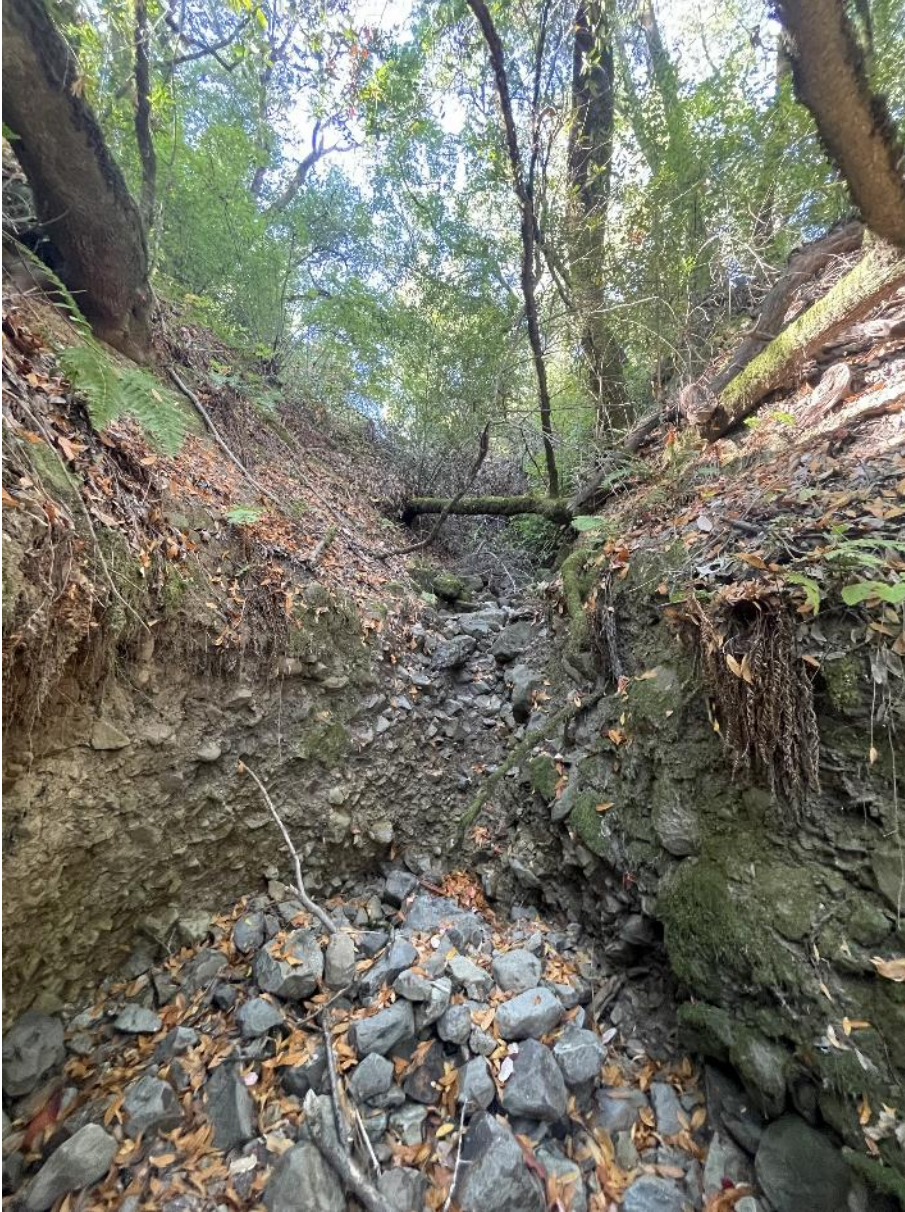
The sluice canyon mentioned above in water retention and infiltration Opportunity #3 is a major source of fine sediments to Asbury and Sonoma Creeks (Figure 44). While a fire service road crosses this drainage course below the outlet of the sluice canyon and is subject to repeated washouts (Figure 45), the erosion issue itself is natural and not the result of improper land management practices in the past. Still, this sluice canyon is a major chronic erosion site and the above suggestion of developing a water retention site at the upstream end of the sluice canyon would reduce the erosive flows moving through this area and help reduce fine sediment inputs to Asbury and Sonoma Creeks.

Figure 44: Chronic Erosion Site #5, Headcut at Sluice canyon outlet. Erosion occurs all throughout this canyon, at this outlet and further down between there and Asbury Creek.

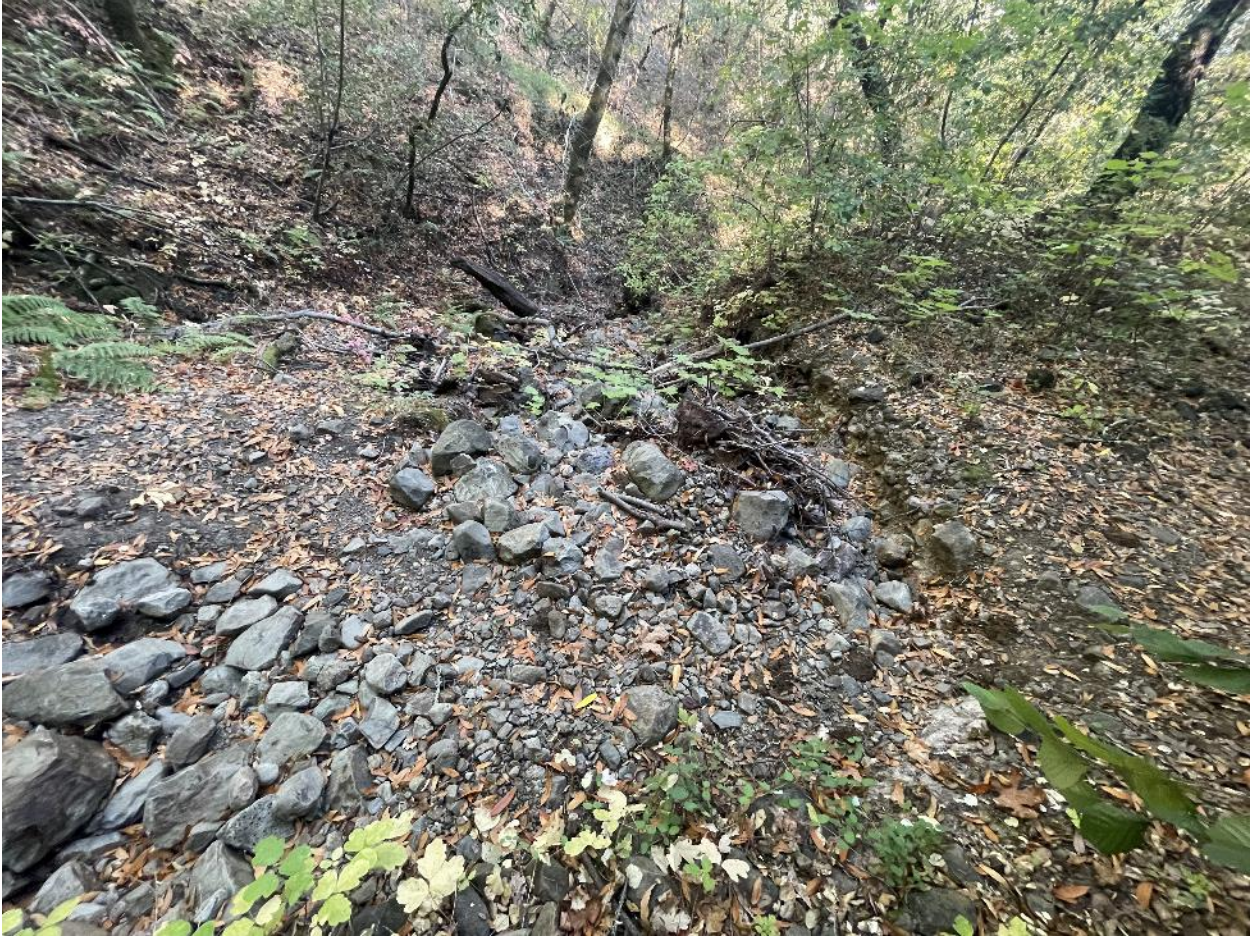
Figure 45: Chronic Erosion Site #5, Wash across fire service road shown along with additional erosive area further below that.

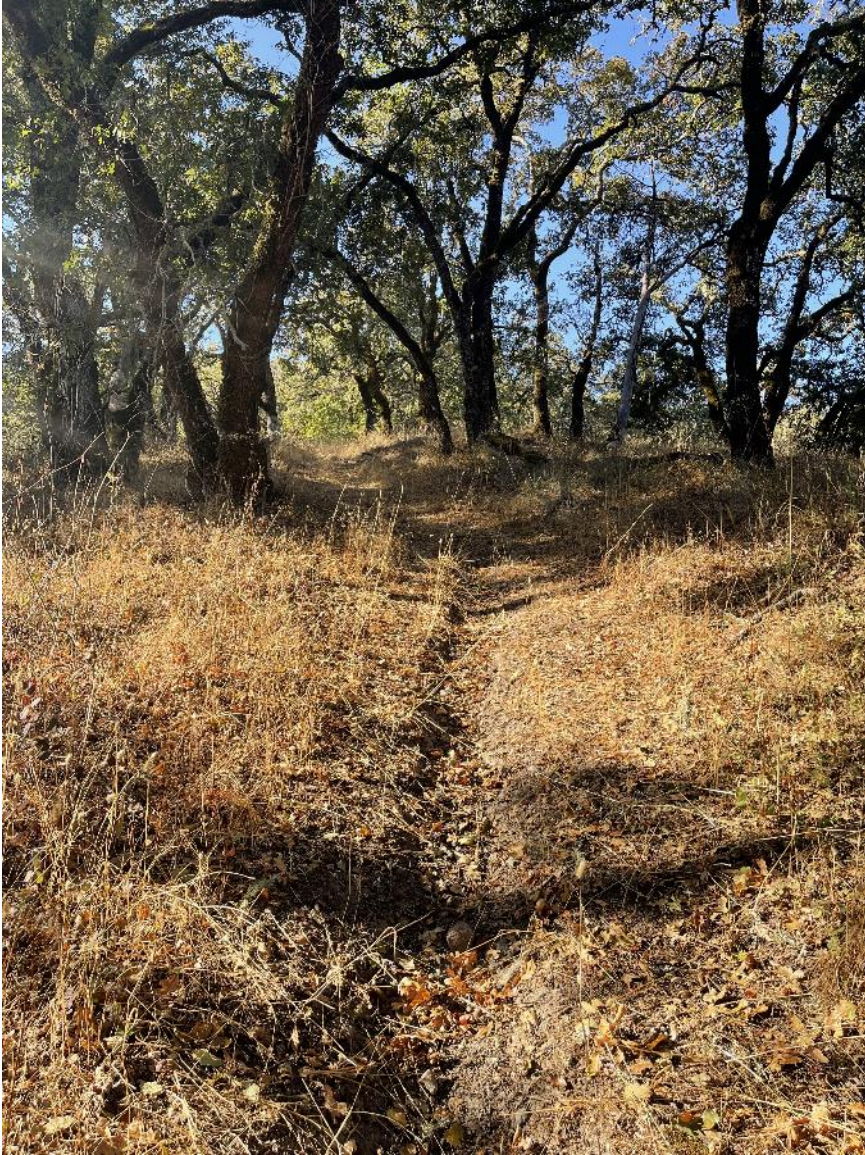
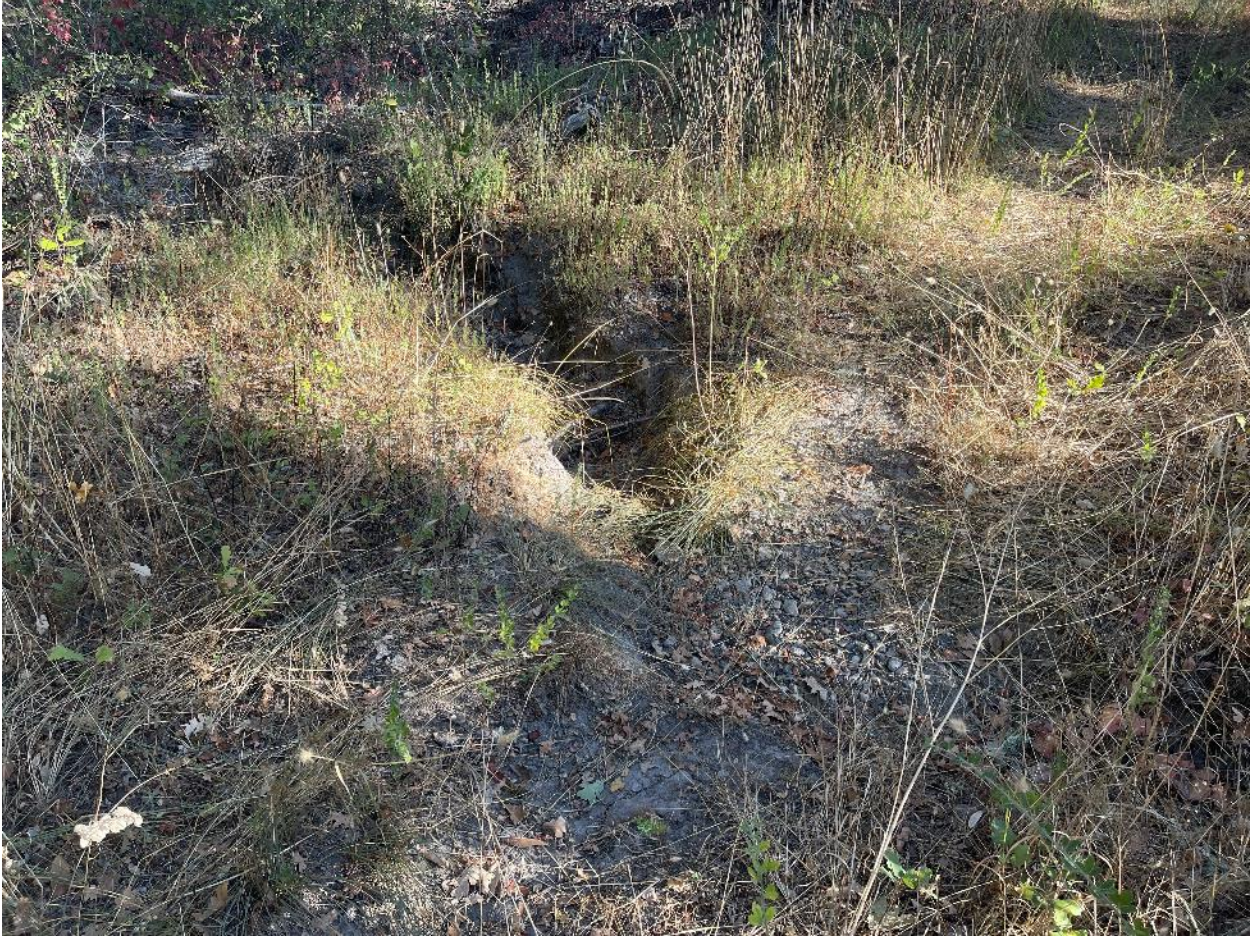
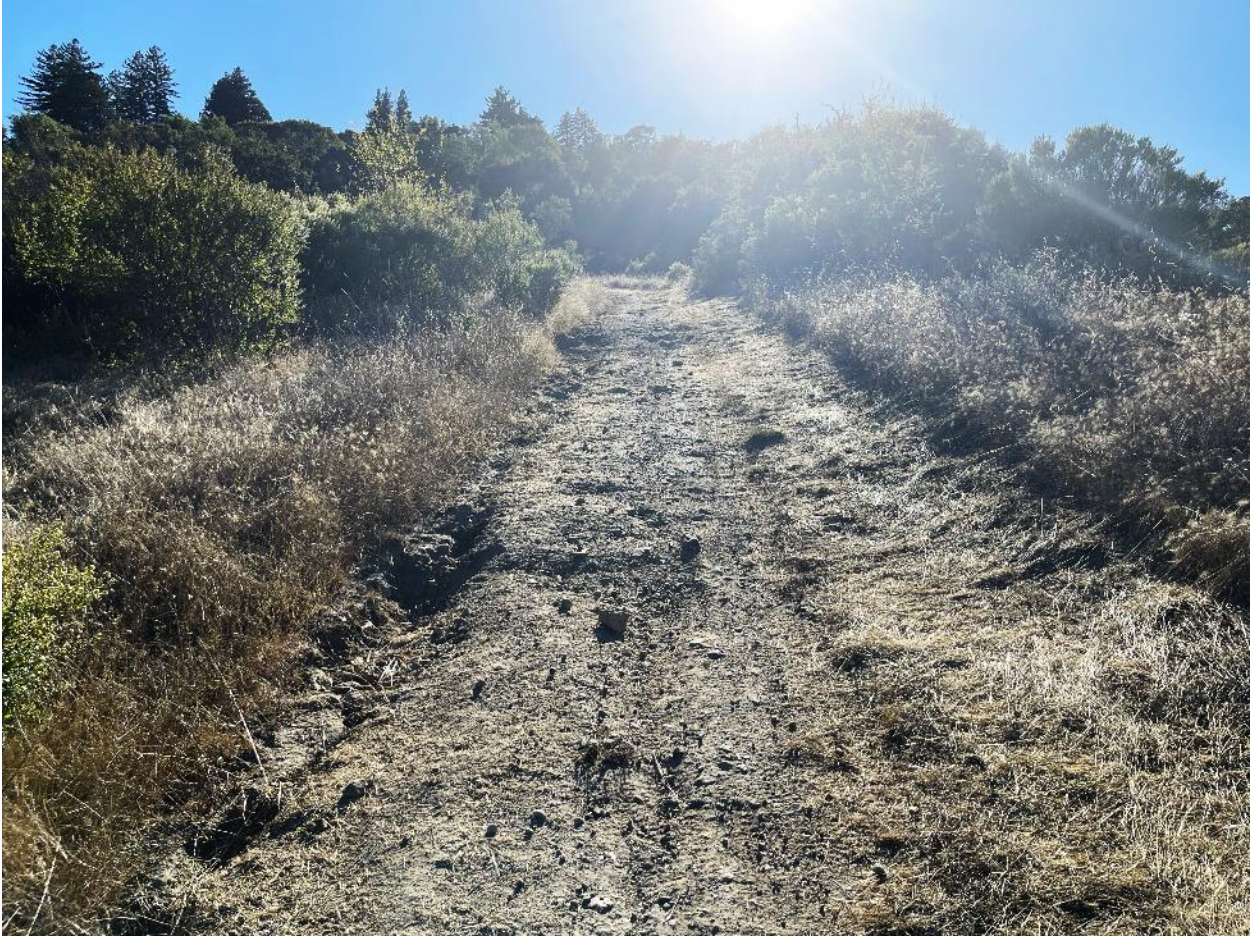
Many of the roads and trails traversing the SDC open space areas were constructed in the early days before we started thinking so much about erosion and watershed health. Several of these roads remain important with respect to emergency response and fire suppression, but their lack of adequate management over the past few decades has allowed for the development of road downcutting and gully formation. There had been a collection of horse enthusiasts riding frequently on these fire roads until the 2017 fires eliminated their boarding facilities in the SDC farm area. These horse riders, and also the mountain bike riders who have been increasingly using these in the time since, have the tendency to ride down the same beaten path each time. On steep sections of fire road, this leads to rill formation and, if not addressed, gully formation. As these lands transition to other land management agencies (e.g., State Parks) the assumption is that most of these fire roads will continue to exist as public trails. Within the western open space, one such fire service road which runs along a section of lower Asbury Creek (see Ero #6 in Figure 4) is really too steep throughout most of its

progression for continued use as a pedestrian and riding trail. Due to horse traffic in the past the road is already v-shaped with a recurring rivulet running down the central pathway during and after rain events (Figure 46). This section of road is a chronic erosion site, creating turbid runoff which makes its way to Asbury Creek, including through one particular headcutting zone (Figure 47). At the top of this steep road, a branching section of road drops steeply down with additional rutting and erosion to the road washout area shown in Figure 12. This location is also critical to wildlife as the adjacent section of the Asbury Creek canyon represents an important north-south and east-west movement corridor for animals. It would be nice if this service road could be regraded and kept in place for emergency fire access, but without being developed and included in any future, codified trail network. An adjacent road on this same sloping hill has also seen increased rilling and gully formation in recent years (Figure 48), especially given the combination of seep drainage and adobe soils occurring there. However, this road is a primary fire service route and it has become a popular recreational artery (referred to as the Carolyn Day Trail) as the institution stopped policing its no-access policy. Thus, it is less practical to close this road off completely to public access. That said, the progression of this road through the most critical pinch point of the wildlife corridor along with the lack of parking development opportunities at its intersection with Arnold Drive mean that this route should not become a primary public access point in the future.

Figure 46: Chronic Erosion Site #6, Steep fire service road along lower Asbury showing deep v erosion caused by horse and mountain bike riders following the same path each time and then rivulets deepening that pathway during rain events.

Figure 47: Chronic Erosion Site #6, Headcutting across fire service road as a result of concentrated flow running down middle of road from steeper sections uphill.

Figure 48: Chronic Erosion Site #6, Rill and gully erosion on a steep section of a primary fire service road running through the western SDC open space within the Sonoma Valley Wildlife Corridor. A seep occurs at the top of the steep section and hikers, bikers and horseback riders using this adobe laden route during the wet season continually promote rill and gully erosion here.

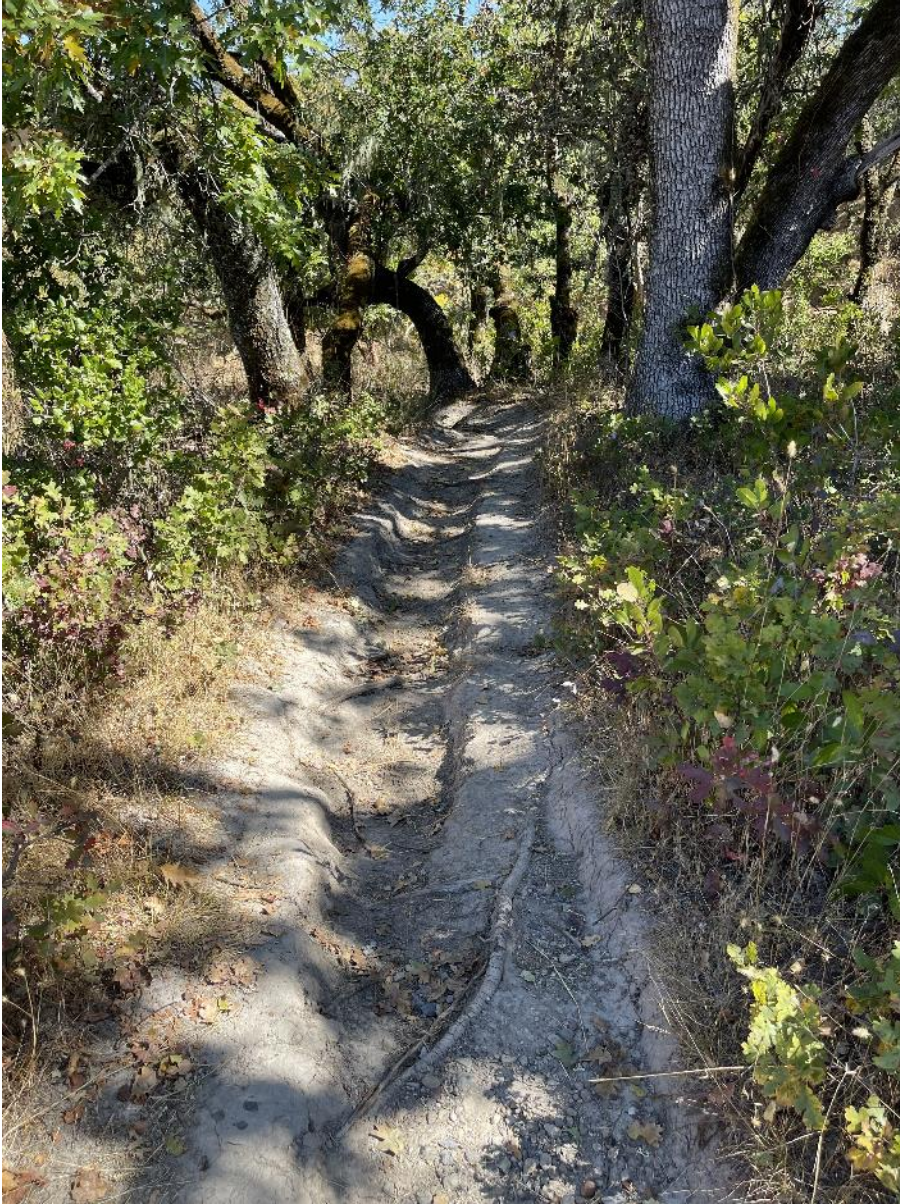
Throughout the history of SDC, fire service roads were all that was found within the managed lands we now think of as wildlife corridors and open space. The public was not allowed onto these lands and even facility employees were not allowed to roam there without specific permissions. Hence, single track walking paths did not exist. Things became much more *laissez faire* over the past 20 years or so as the institution retracted and moved further toward closure. Employees began exploring the open space lands more and more, especially as health and fitness became more of a cultural goal at the institution. Several single track walking paths developed over this time including one extending from the Paxton Goddard area of campus up to the main fire service road below Fern Lake (see Ero #7 in Figure 4). This trail is very steep in places, especially in its upper section. Over time, as it was discovered by new users, including horse and mountain bike riders, its adobe soils have eroded turning this path in to a trench which concentrates overland flows during rain events (Figure 49). This path/trench represents a chronic erosion site which adds additional turbidity to the Corridor Creek (north and south) drainages of the SDC subwatershed where we found such high, recurring turbidity. This poorly routed trail needs to be reconsidered and rerouted, especially at its steep upper reach. Instead, it should be routed through the meadow to the north along existing service roads. At its lower reach, this same path crosses through the Corridor Creek south channel two times (one crossing is

Figure 49: Chronic Erosion Site #7, heavy erosion along steep and ill-sited employee use trail just north of water treatment plant. This single track trail has become popular among mountain bike riders including during the wet season when such uses of adobe soil trails should be discouraged.

shown in Figure 50). There is favorable grade in this area to reroute this trail without the need for these channel crossings. Doing so would also allow the primary public ingress/egress route to remain on the periphery of the most critical portion of the wildlife corridor. Currently, that primary route ascends and descends a very steep hilltop on its way into the bowl area mentioned in water retention Opportunity 4. That fire service road should remain in place for emergency use, but future public movements should be routed away from this area.

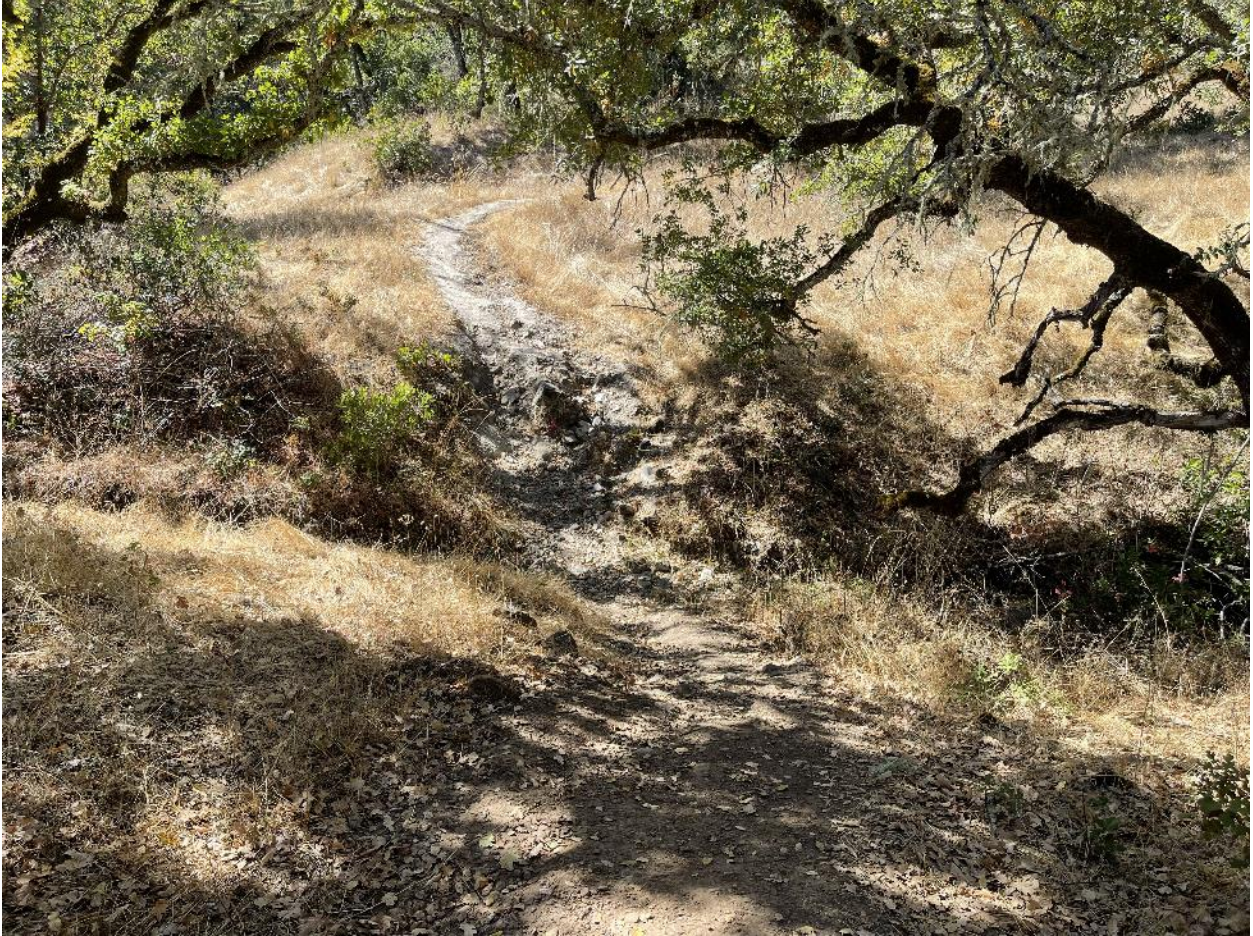
Figure 50: Chronic Erosion Site #7, One of two stream channel crossing points on single track employee use trail which has become popular among mountain bike riders including during the wet season when such uses of adobe soil trails should be discouraged.

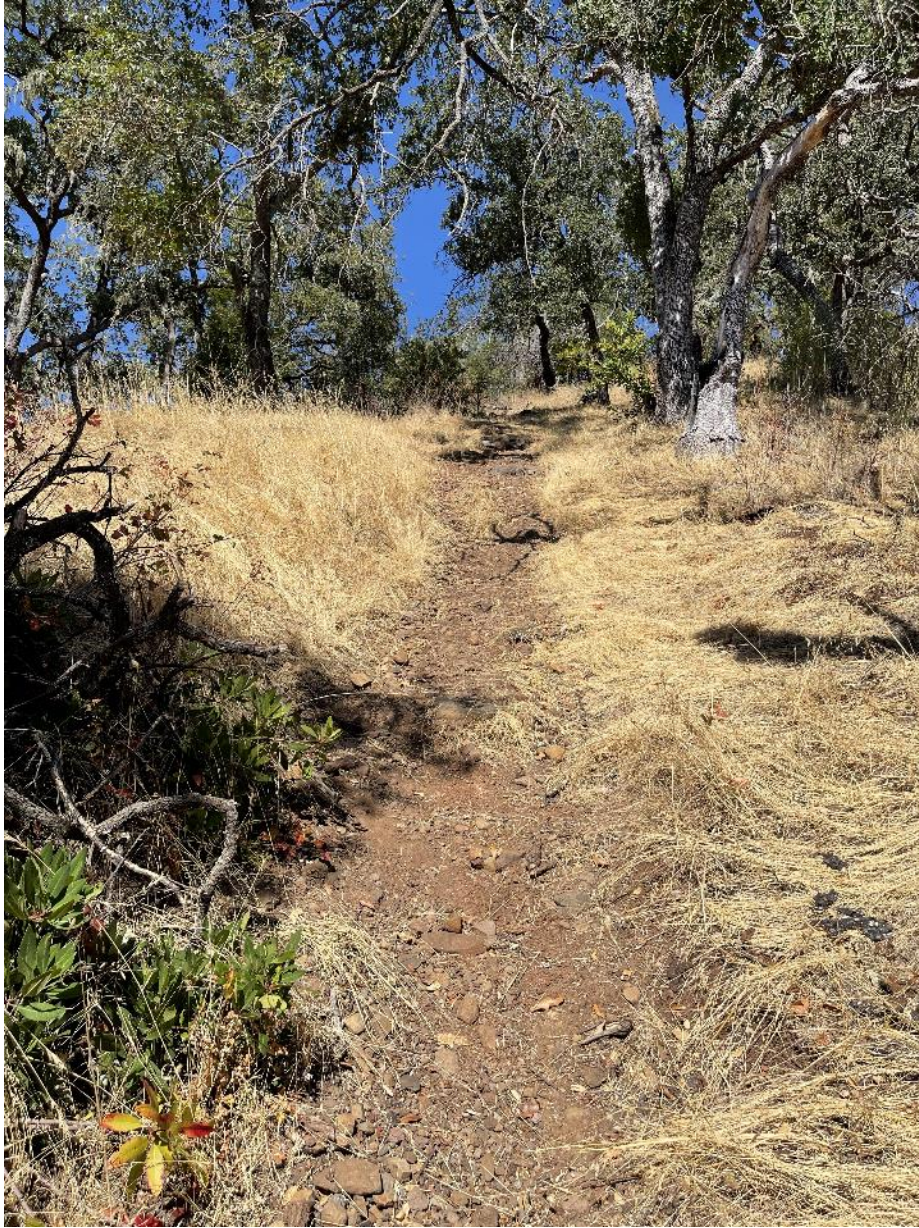
On the east side of Sonoma Creek between the Lake Suttonfield dam and the entrance to the Sonoma Valley Regional Park, exists an almost impossibly steep fire access road which ascends in a nearly straight line up to the summit of the adjacent hilltop (see Ero#8 in Figure 4). This hillside and most of the surrounding hilltops remain SDC property, but have popularly become known as part of the Regional Park due to its contiguity and interconnectedness. During the dry season, and with proper grading, this road section is passable by 4 wheel drive emergency vehicles, but over the past 20 years of waning management, this section has deeply rutted and become a chronic erosion site (Figure 51). It is also quite a hazard since hikers and mountain bikers approaching from the uphill side often realize too late how steep and slippery this steep section is. Due to its steepness, and because other routes toward this hilltop are available for emergency access, this section of fire service road should be eliminated and restored.

Figure 51: Chronic Erosion Site #8, Impossibly steep, former fire service road northwest of the Lake Suttonfield dam with rutting evident. This trail is still being used by hikers and mountain bikers transiting south from the Sonoma Valley Regional Park trails with moderate safety risk of doing so.
